TREE REPORT

9832 Wanda Park Dr.
Los Angeles, CA 90210

Prepared by
Harmony Gardens
12224 Addison St.
Valley Village, CA 91607
Phone 818-505-9783
Shelley Sparks, RLA # 2896, ASLA
ISA Certified Arborist #WE-10883A

16 September 2022

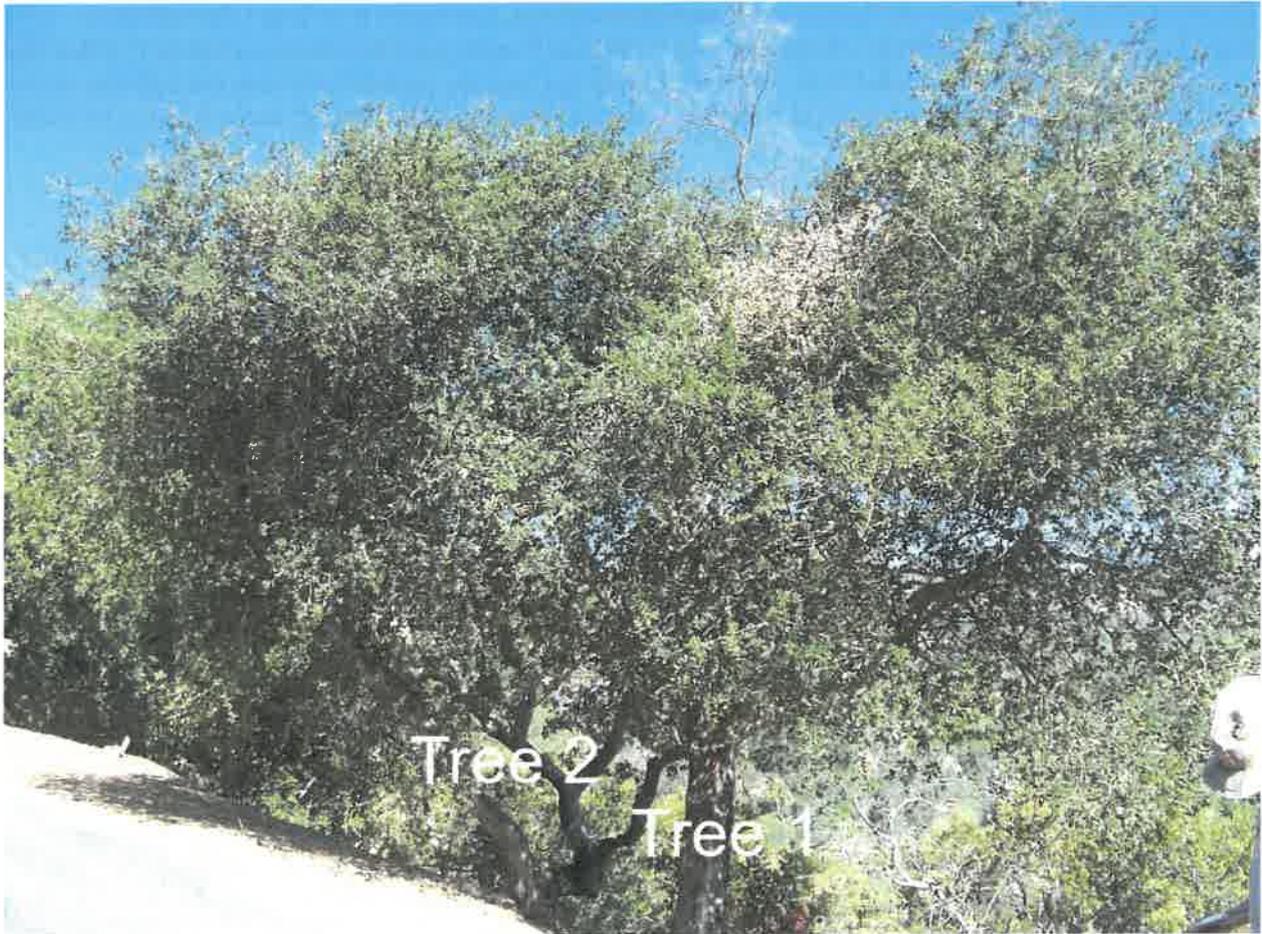
Tree 1 is *Quercus agrifolia*, Coast Live Oak, in good condition with some dieback at the top. It is 16' high and 20' wide with an 11" caliper. This tree will be unaffected by the construction, however, should it be removed, mitigation value is four 24"-box trees of the same variety, *Quercus agrifolia*.

Tree 2 is *Quercus agrifolia*, Coast Live Oak, in good condition with a leaning posture and poor pruning. It is 15' high and 8' wide with a 6" caliper. This tree will be unaffected by the construction, however, should it be removed, mitigation value is four 24"-box trees of the same variety, *Quercus agrifolia*.

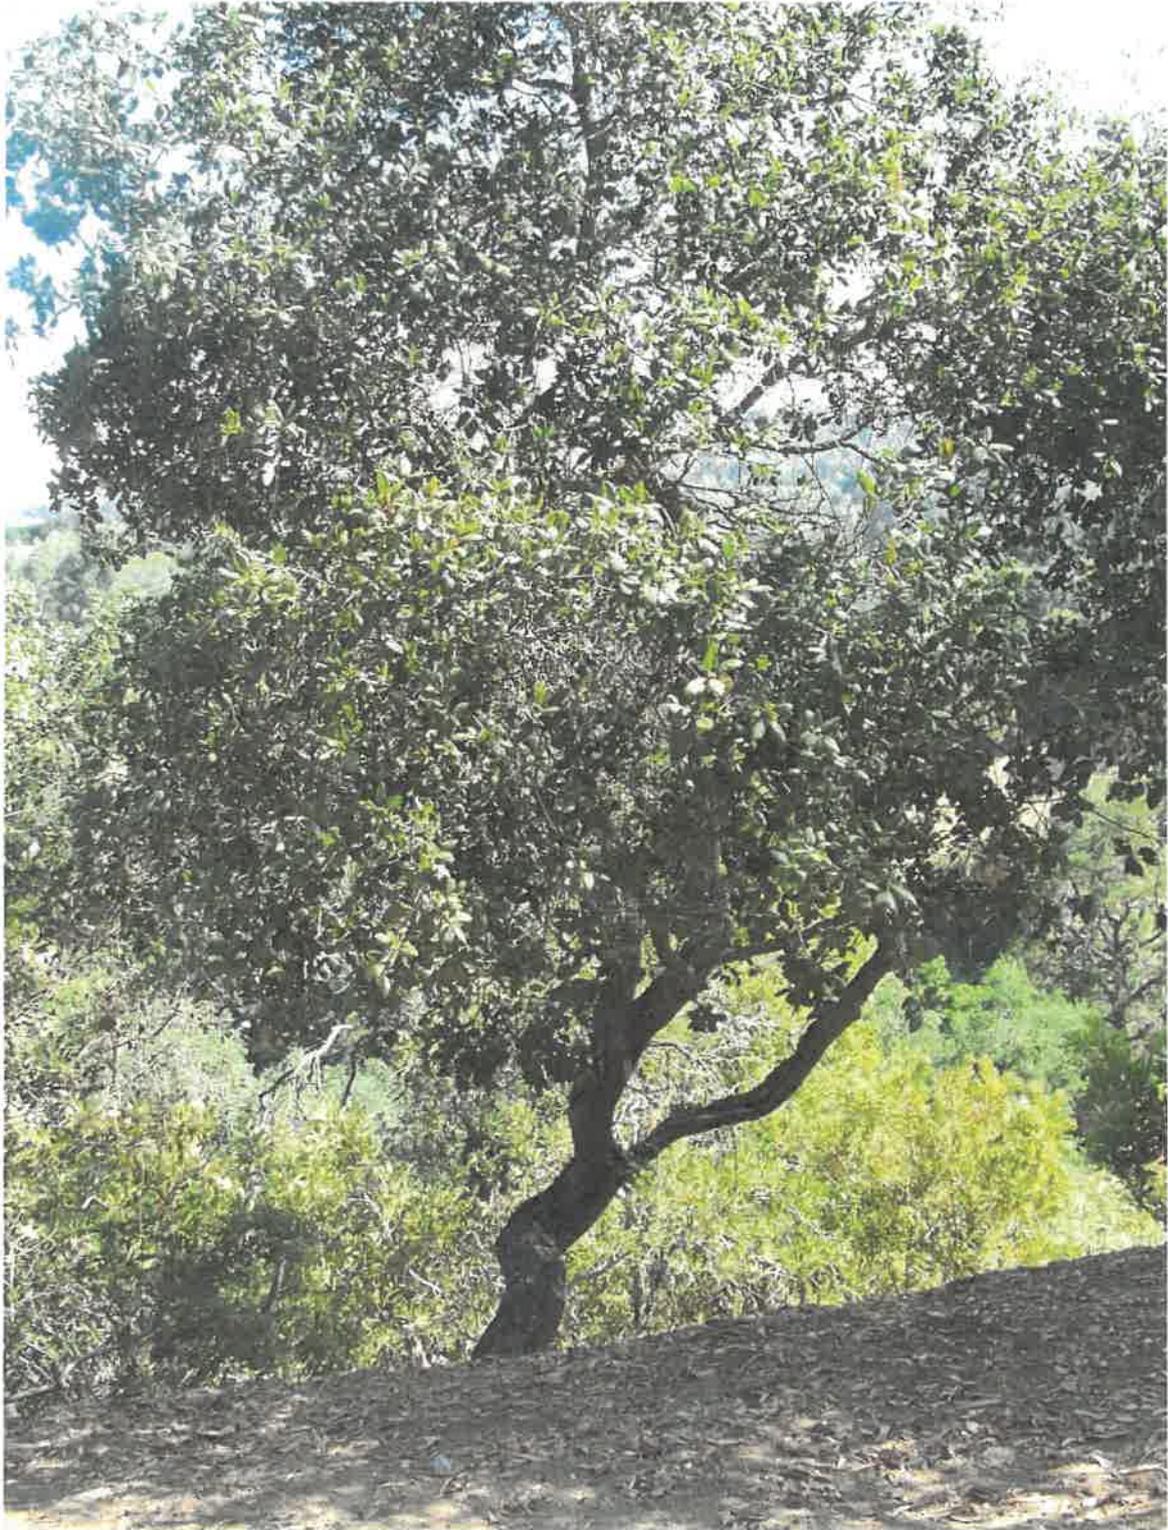
Tree 3 is *Quercus agrifolia*, Coast Live Oak, in good condition with a leaning posture, some dieback, and poor pruning. It is 19' high and 13' wide with a 9" caliper. This tree will be unaffected by the construction, however, should it be removed, mitigation value is four 24"-box trees of the same variety, *Quercus agrifolia*.

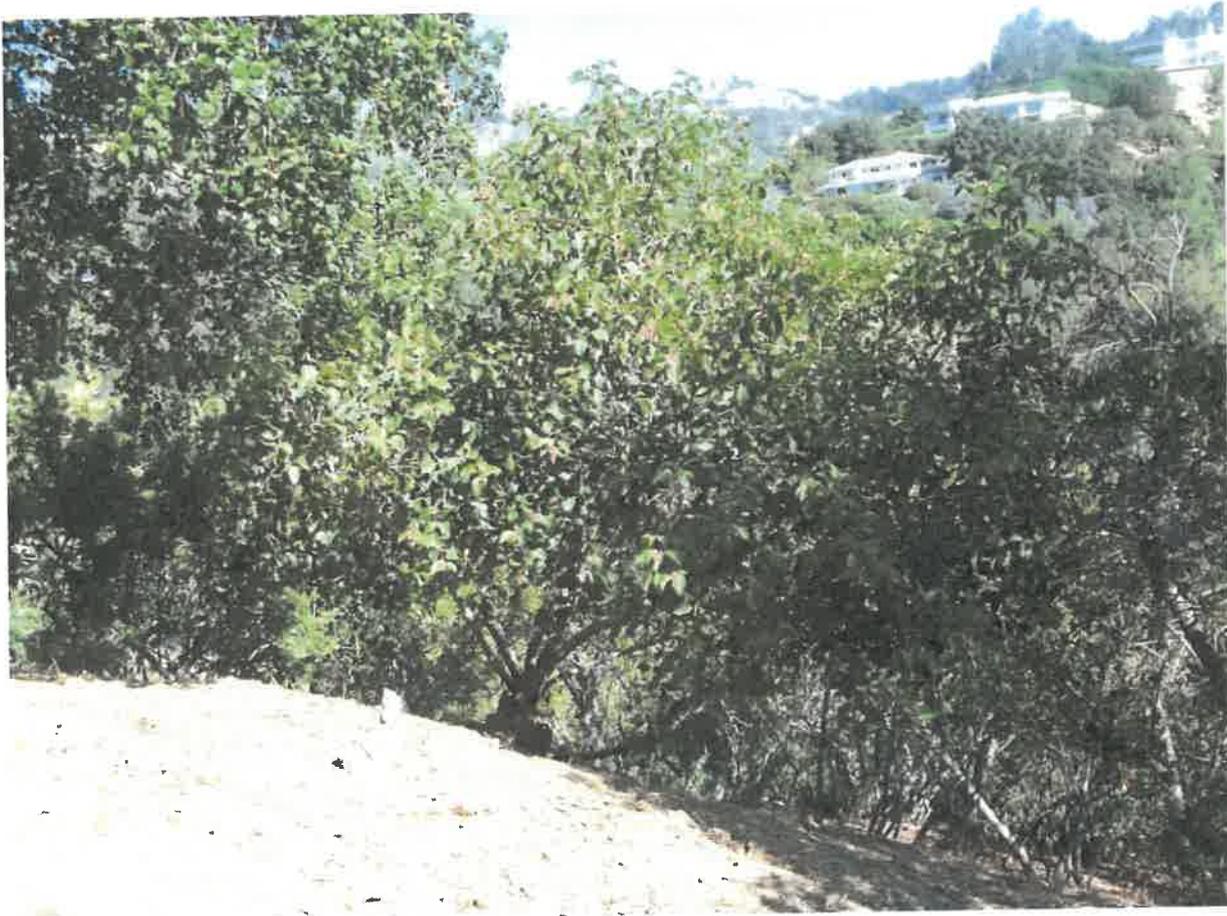
Shrub 4 is *Heteromeles arbutifolia*, Toyon, in good condition despite some drought stress, dieback, and poor pruning. It is 10' high and 8' wide with four 1" and two 2" calipers. This shrub will be unaffected by the construction, however, should it be removed, mitigation value is four 24" box *Heteromeles arbutifolia*.

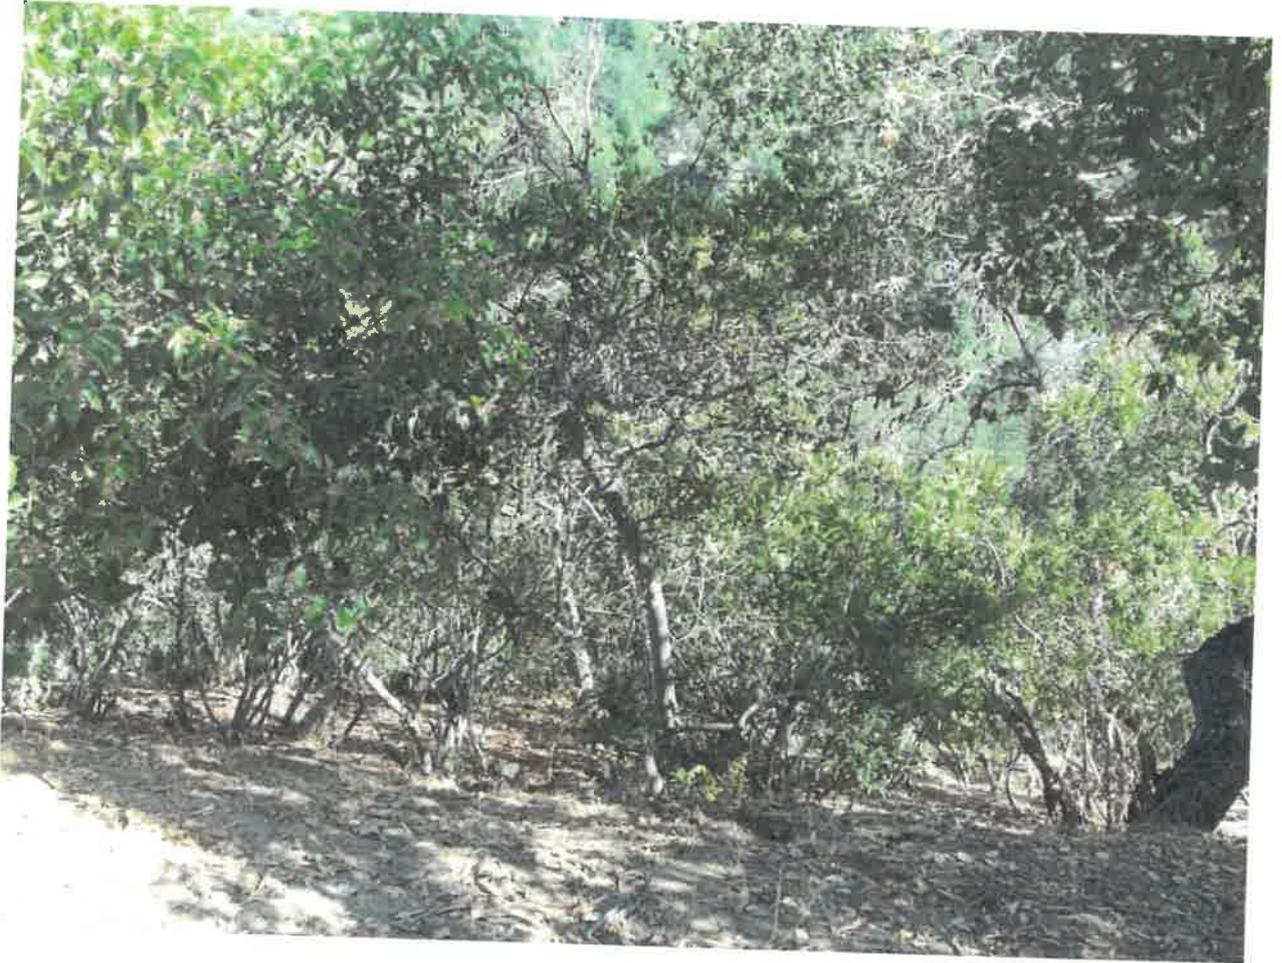
Shrub 5 is *Heteromeles arbutifolia*, Toyon, in fair condition with dieback, scaling, and poor pruning. It is 10' high and 8' wide with four 1" and two 2" calipers. This shrub will be unaffected by the construction, however, should it be removed, mitigation value is four 24" box *Heteromeles arbutifolia*.

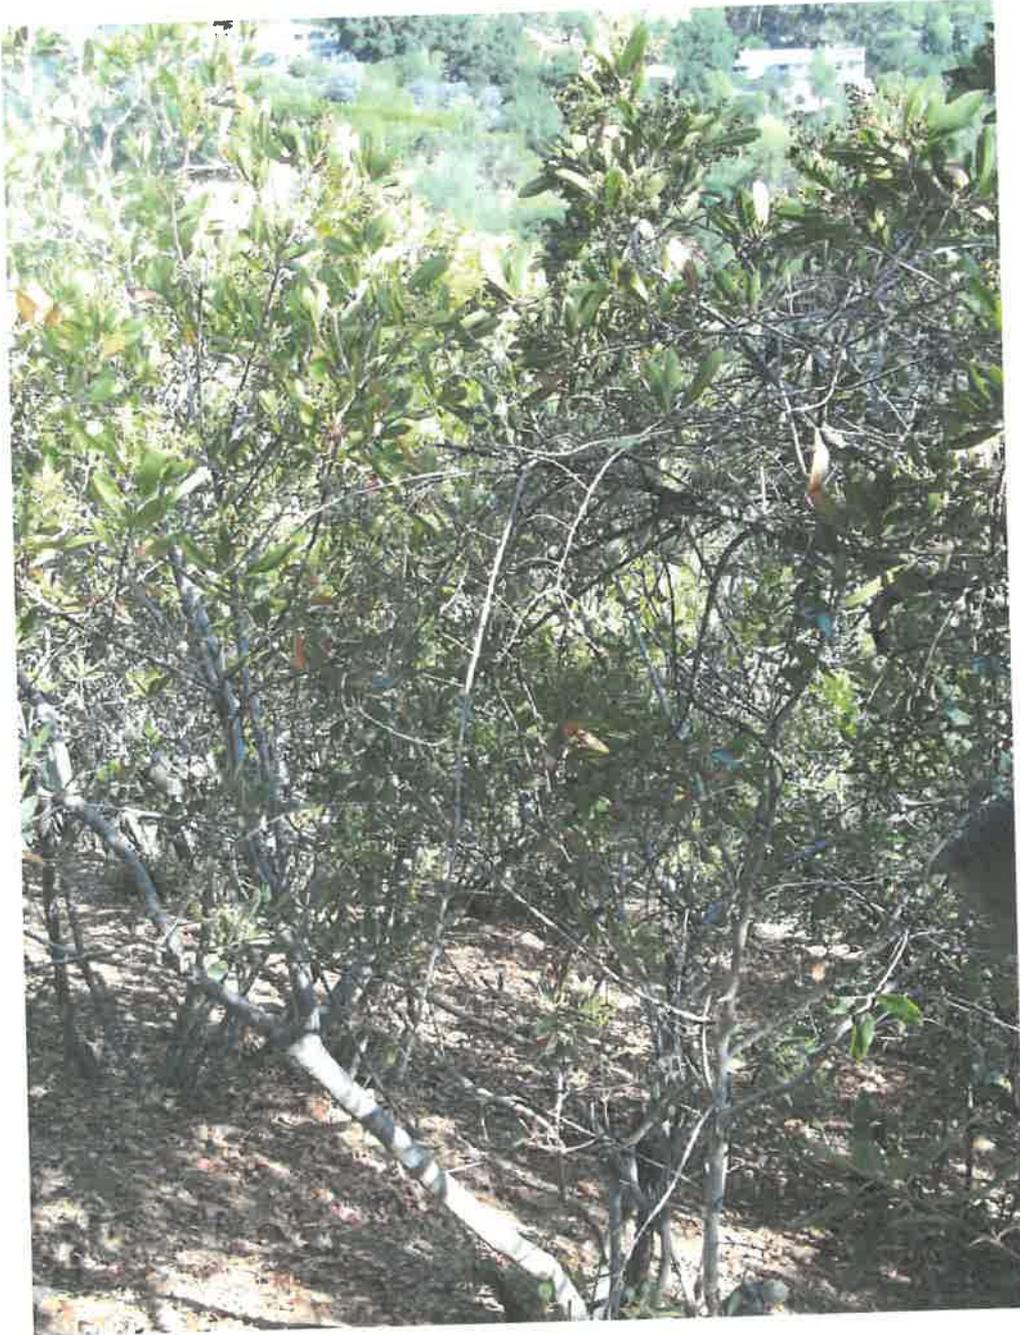
Shrub 6 is *Heteromeles arbutifolia*, Toyon, in fair condition with dieback, and poor pruning. It is 12' high and 12' wide with five 1" and six 2" calipers. This shrub will be unaffected by the construction, however, should it be removed, mitigation value is four 24" box *Heteromeles arbutifolia*.

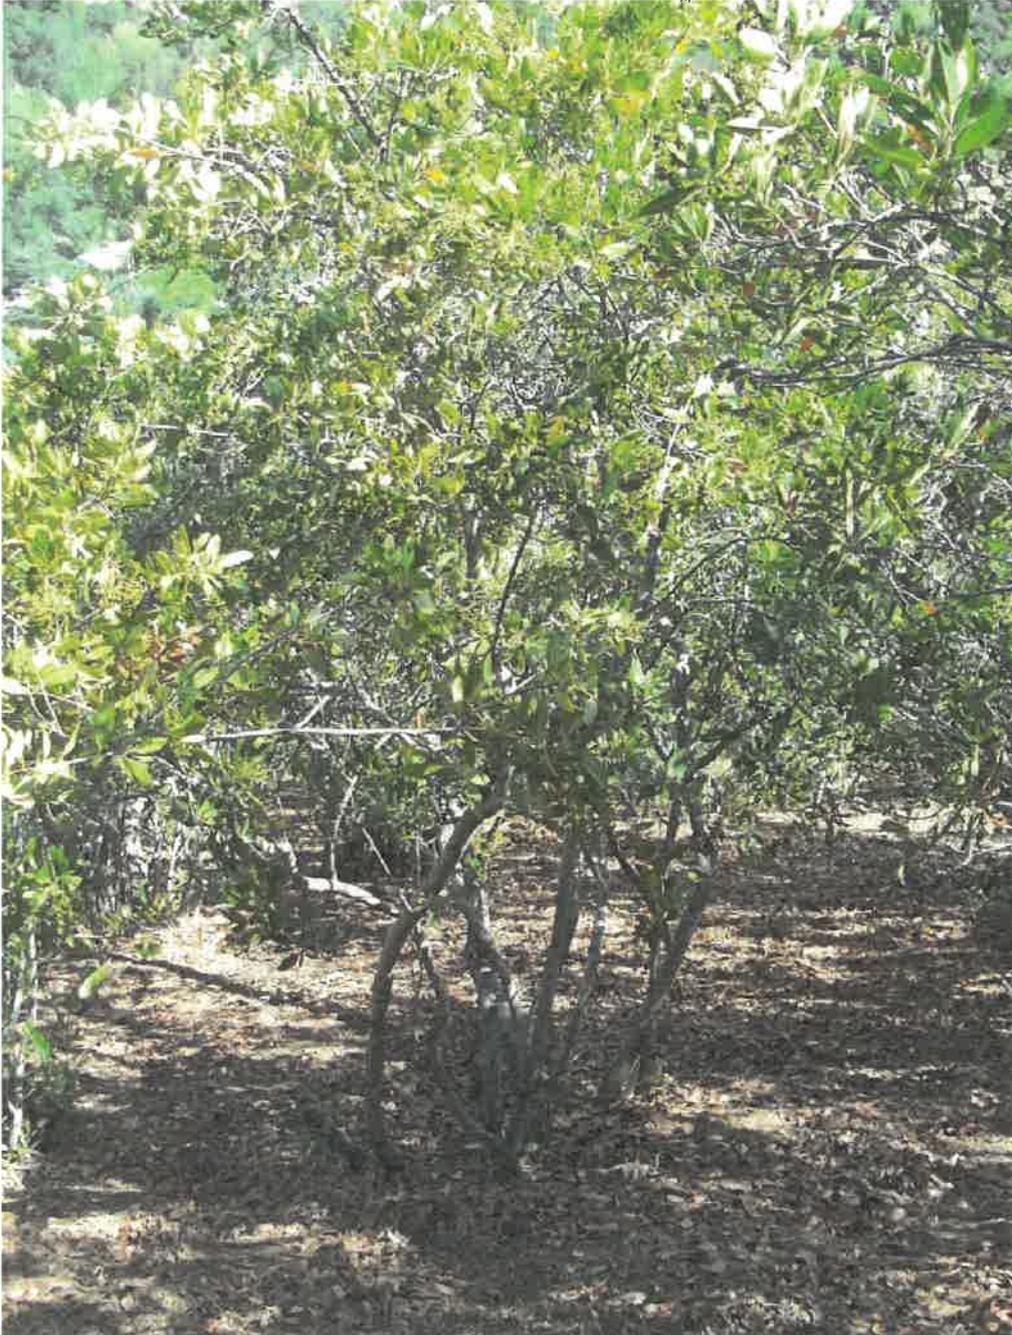
Shrub 7 is *Heteromeles arbutifolia*, Toyon, in good condition with some dieback and poor pruning. It is 10' high and 10' wide with three 1", one 2", and one 3" calipers. This shrub will be unaffected by the construction, however, should it be removed, mitigation value is four 24" box *Heteromeles arbutifolia*.

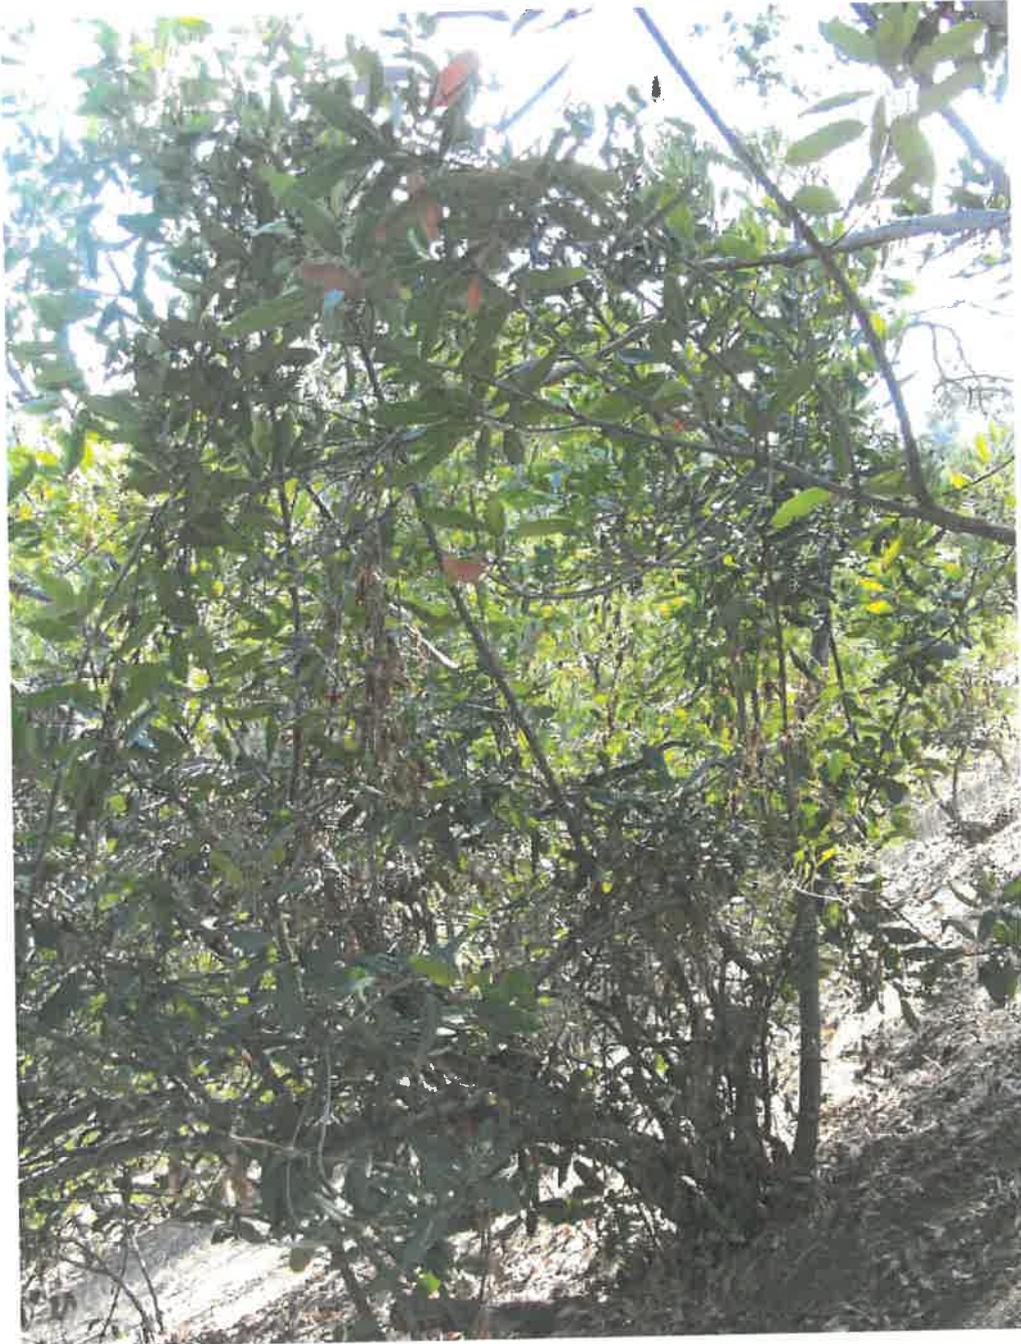
Shrub 8 is *Heteromeles arbutifolia*, Toyon, in fair condition with dieback and poor pruning. It is 19' high and 15' wide with three 1", three 2", one 4", and one 6" calipers. This shrub will be unaffected by the construction, however, should it be removed, mitigation value is four 24" box *Heteromeles arbutifolia*.

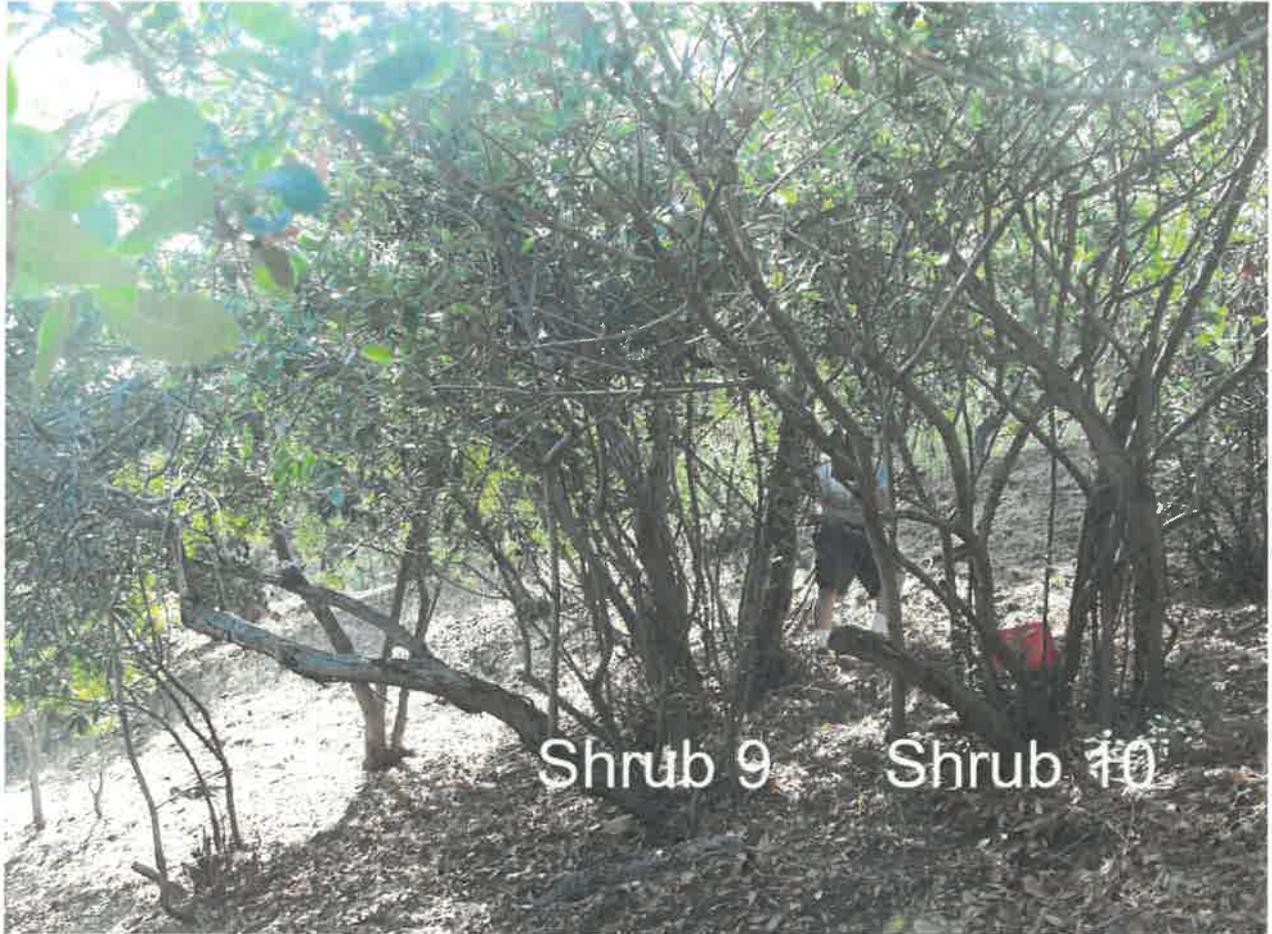
Shrub 9 is *Heteromeles arbutifolia*, Toyon, in nearly dead condition with severe dieback and poor pruning. It is 10' high and 8' wide with nine 1" calipers. This shrub will be unaffected by the construction, however, should it be removed, mitigation value is four 24" box *Heteromeles arbutifolia*.

Shrub 10 is *Heteromeles arbutifolia*, Toyon, in nearly dead condition with drought stress, severe dieback, and poor pruning. It is 10' high and 7' wide with seven 1" and two 2" calipers. This shrub will be unaffected by the construction, however, should it be removed, mitigation value is four 24" box *Heteromeles arbutifolia*.

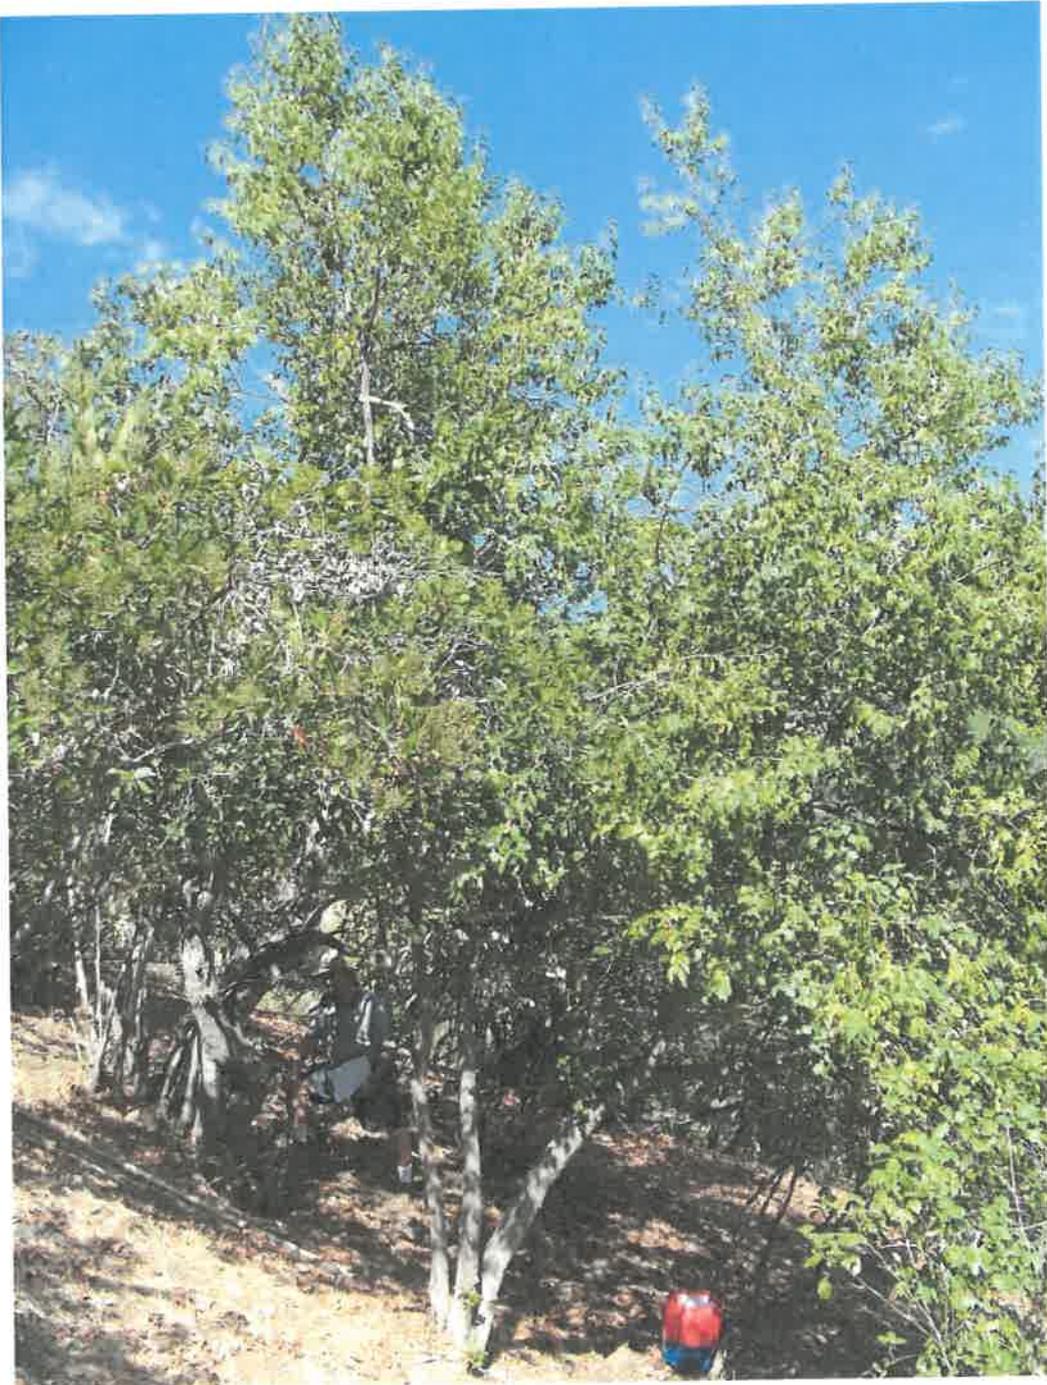
Tree 11 is *Prunus ilicifolia*, Catalina Cherry, in good condition with some dieback and drought stress. It is 23' high and 15' wide with two 1", one 3", and one 5" calipers. This tree will be unaffected by the construction, however, should it be removed, mitigation value is one 24"-box tree.

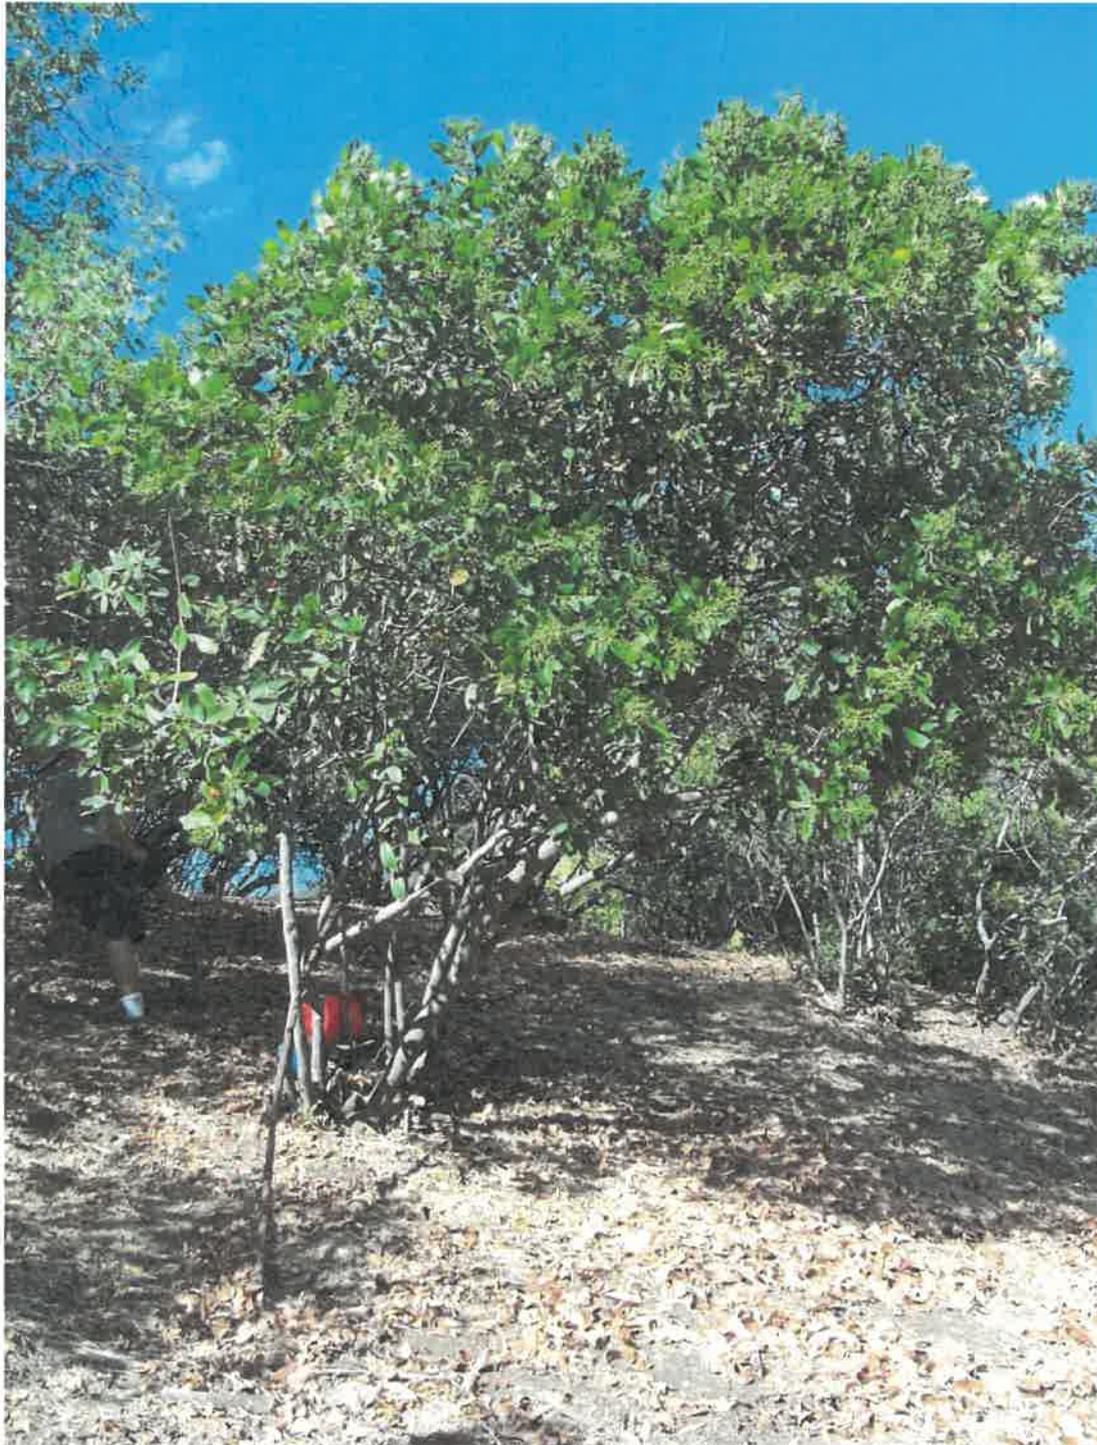
Shrub 12 is *Heteromeles arbutifolia*, Toyon, in good condition with some drought stress, a leaning posture, and poor pruning. It is 14' high and 12' wide with three 1", six 2", one 3", and one 4" calipers. This shrub will be unaffected by the construction, however, should it be removed, mitigation value is four 24" box *Heteromeles arbutifolia*.

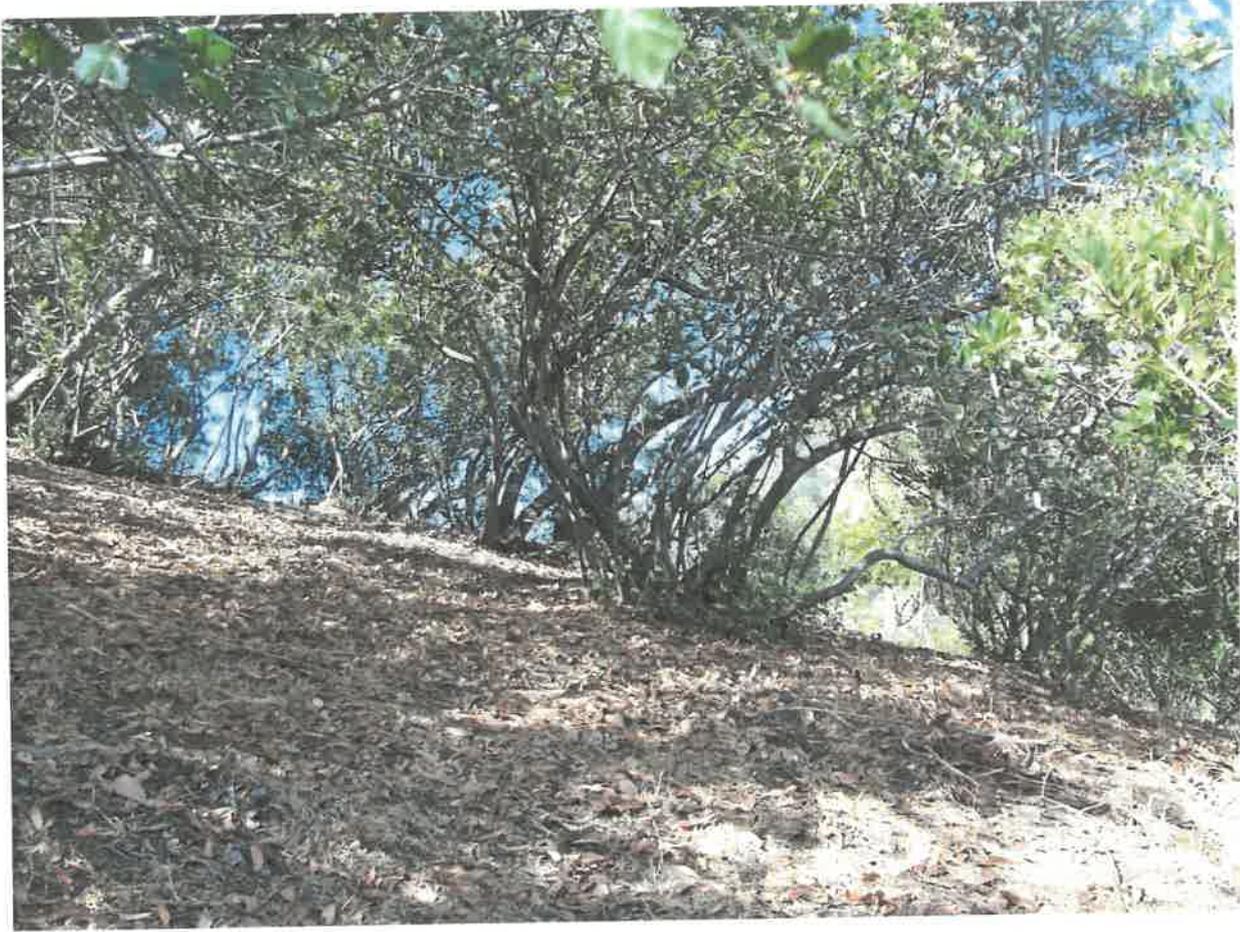
Shrub 13 is *Heteromeles arbutifolia*, Toyon, in fair condition with some drought stress, dieback, and poor pruning. It is 9' high and 12' wide with twelve 1", two 2", one 3", and one 4" calipers. This shrub will be unaffected by the construction, however, should it be removed, mitigation value is four 24" box *Heteromeles arbutifolia*.

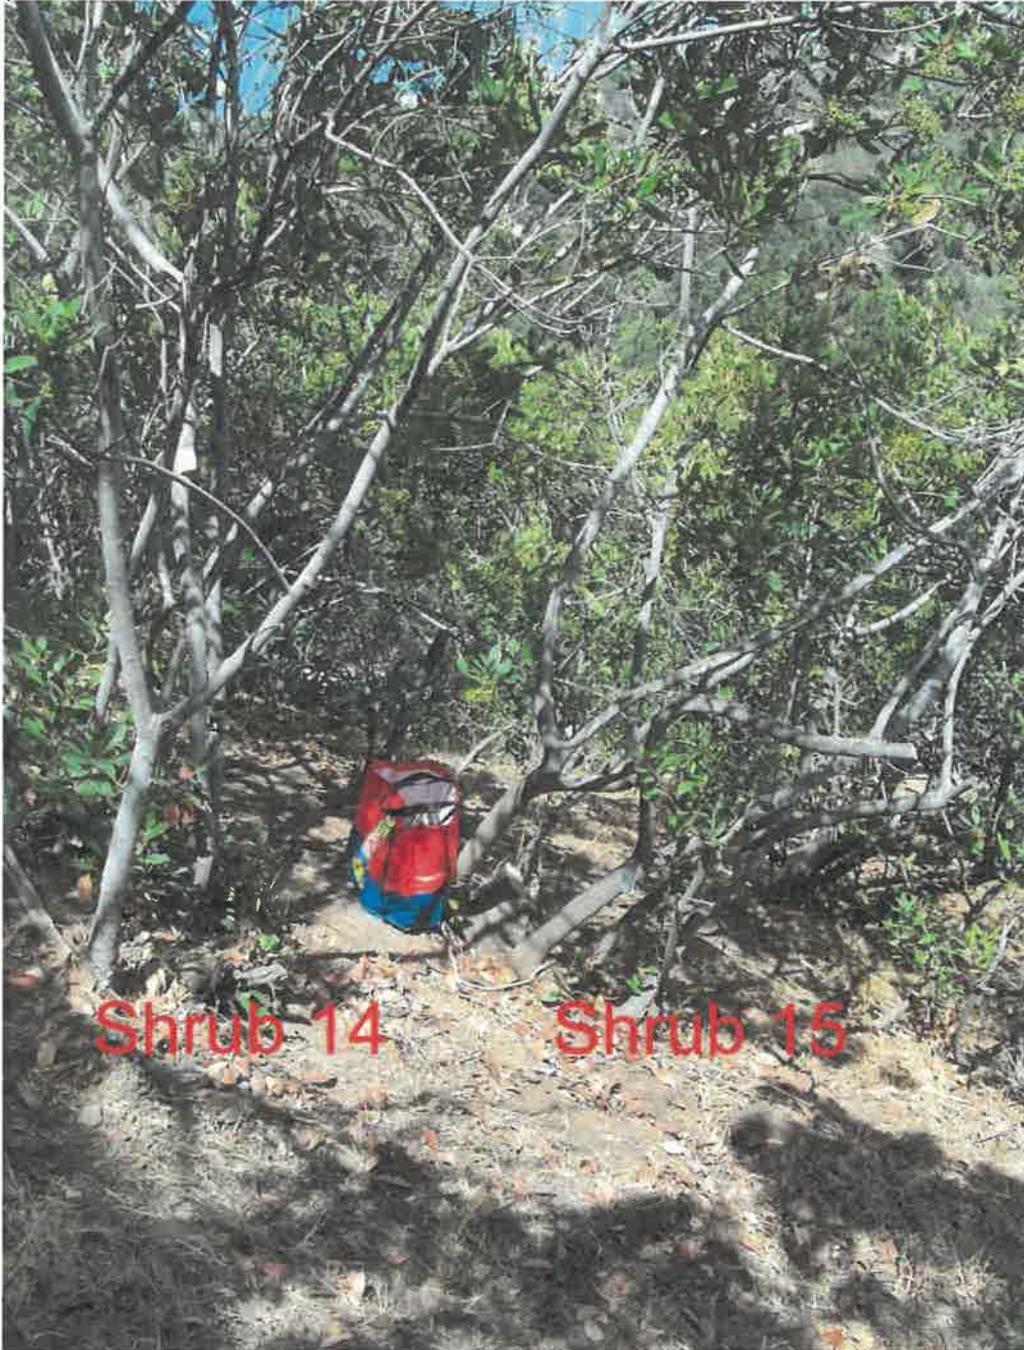
Shrub 14 is *Heteromeles arbutifolia*, Toyon, in fair condition with drought stress, dieback, and poor pruning. It is 12' high and 10' wide with seven 1" and four 2" calipers. This shrub will be unaffected by the construction, however, should it be removed, mitigation value is four 24" box *Heteromeles arbutifolia*.

Shrub 15 is *Heteromeles arbutifolia*, Toyon, in fair condition with drought stress, dieback, and poor pruning. It is 10' high and 8' wide with five 1" and two 2" calipers. This shrub will be unaffected by the construction, however, should it be removed, mitigation value is four 24" box *Heteromeles arbutifolia*.

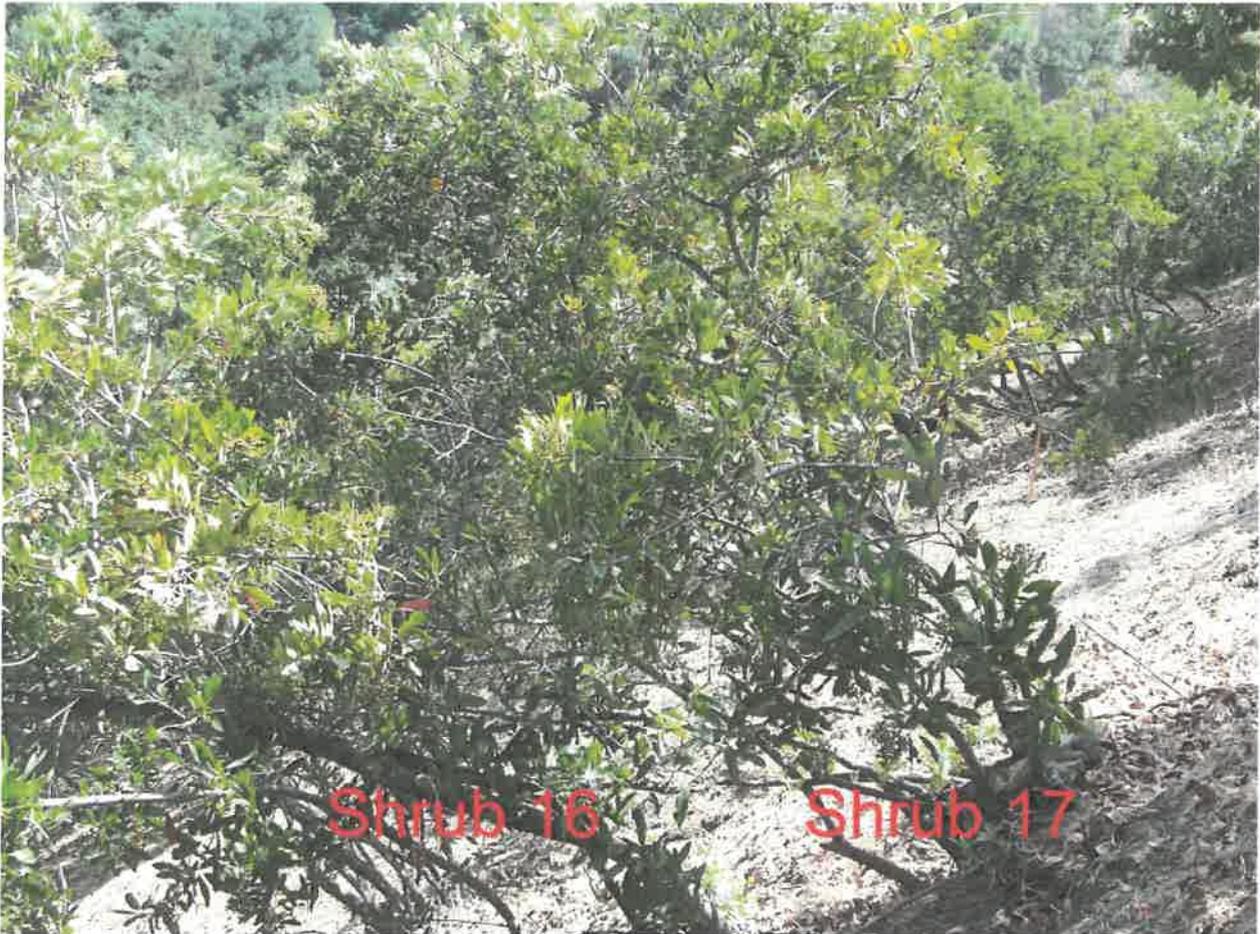
Shrub 16 is *Heteromeles arbutifolia*, Toyon, in good condition with some drought stress, dieback, and poor pruning. It is 9' high and 12' wide with three 1" and three 2" calipers. This shrub will be unaffected by the construction, however, should it be removed, mitigation value is four 24" box *Heteromeles arbutifolia*.

Shrub 17 is *Heteromeles arbutifolia*, Toyon, in good condition with some drought stress, dieback, and poor pruning. It is 9' high and 14' wide with calipers of 1", 2", 3", and 4" calipers. This shrub will be unaffected by the construction, however, should it be removed, mitigation value is four 24" box *Heteromeles arbutifolia*.

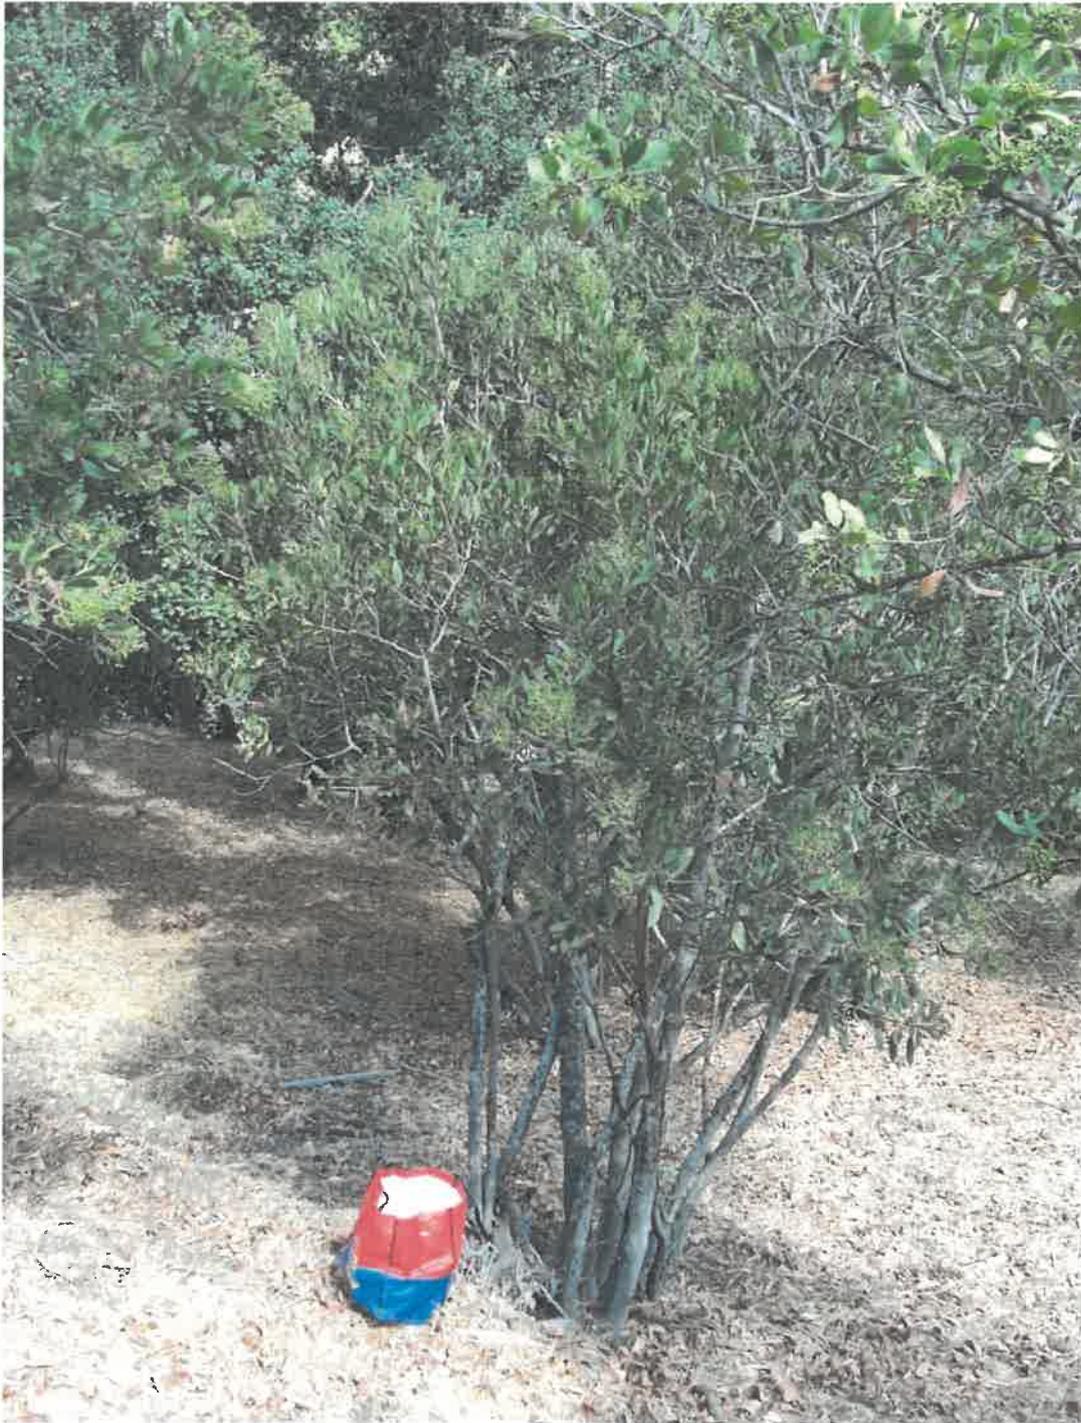
Shrub 18 is *Heteromeles arbutifolia*, Toyon, in good condition with some drought stress, dieback, and poor pruning. It is 10' high and 15' wide with seven 1", six 2", and one 3" calipers. This shrub will be unaffected by the construction, however, should it be removed, mitigation value is four 24" box *Heteromeles arbutifolia*.

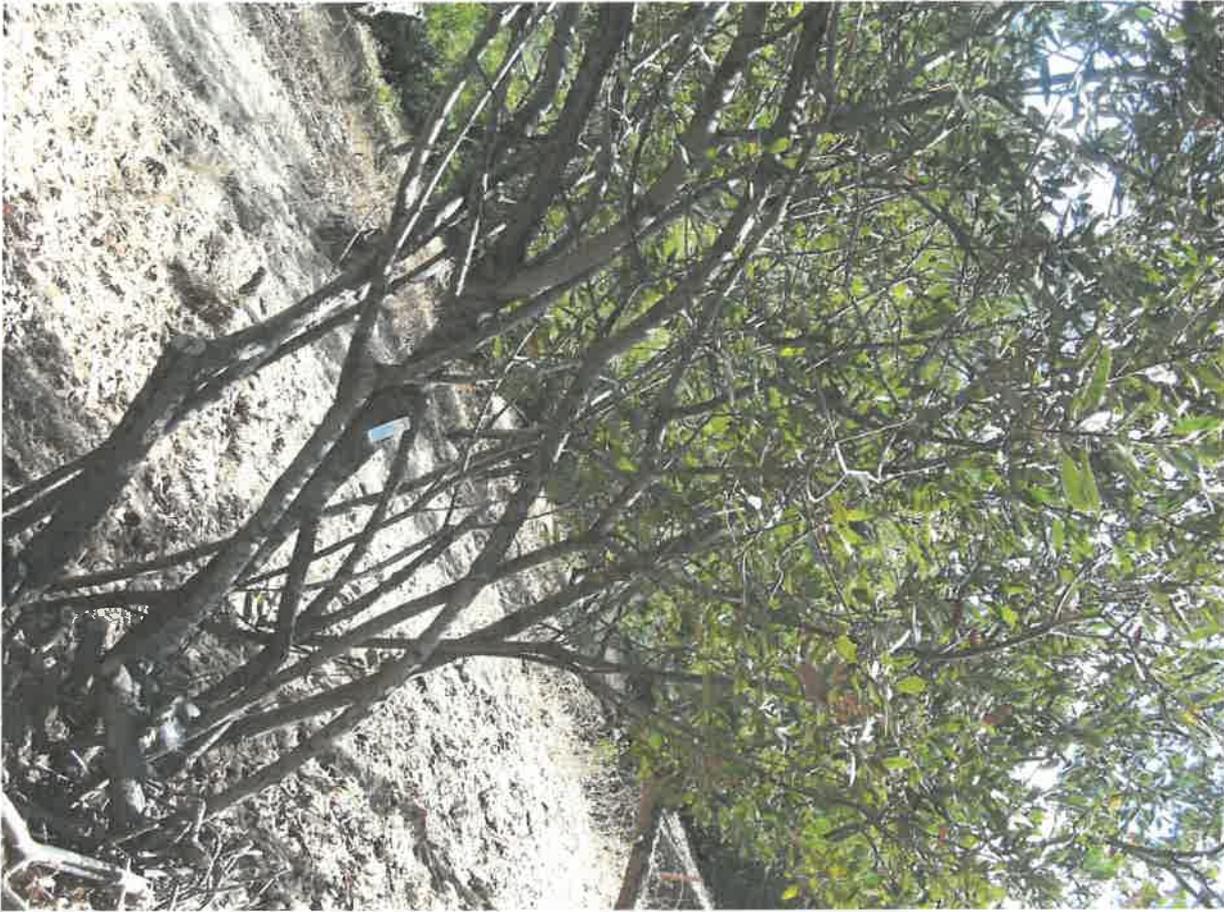
Shrub 19 is *Heteromeles arbutifolia*, Toyon, in fair condition with drought stress, dieback, and poor pruning. It is 10' high and 13' wide with five 1", three 2", and three 3" calipers. This shrub will be unaffected by the construction, however, should it be removed, mitigation value is four 24" box *Heteromeles arbutifolia*.

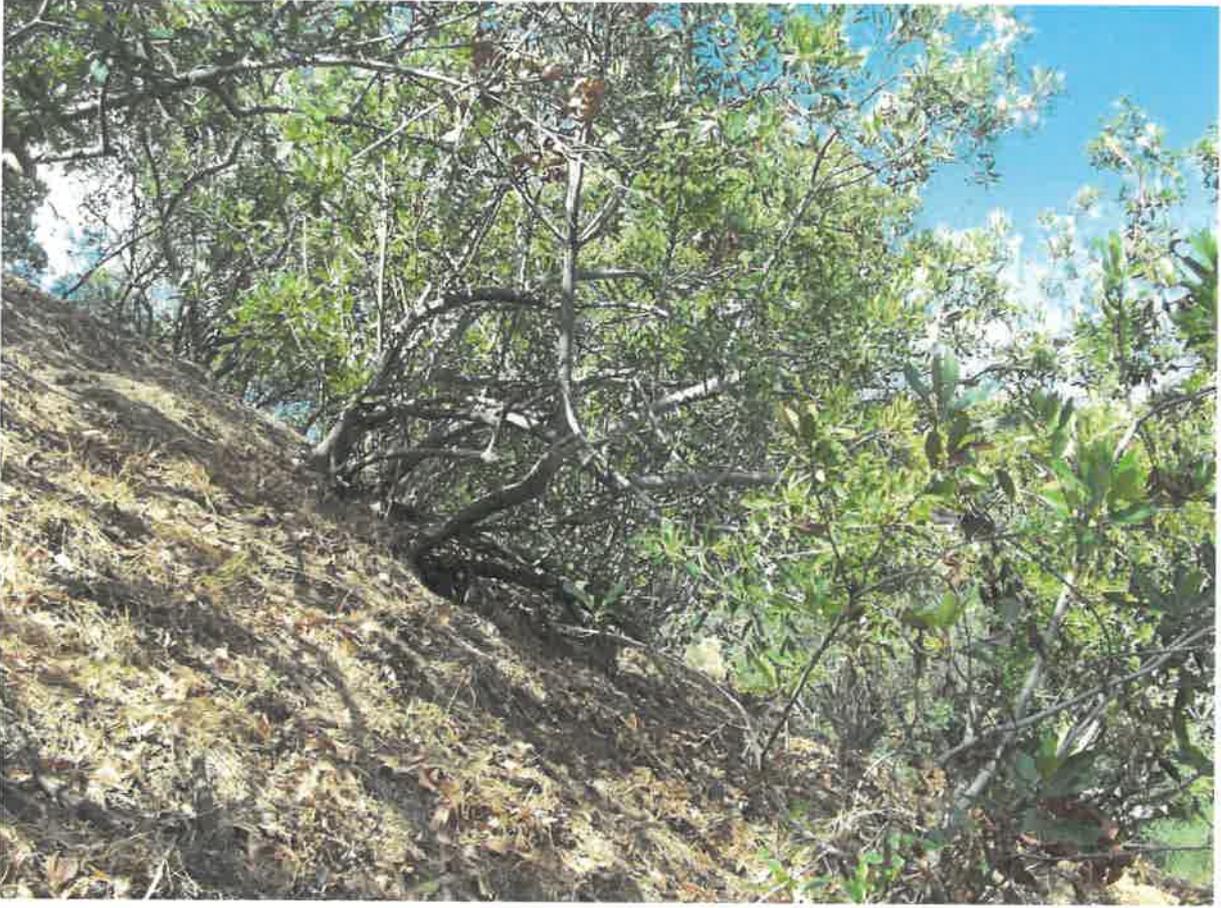
Shrub 20 is *Heteromeles arbutifolia*, Toyon, in fair condition with drought stress, dieback, and poor pruning. It is 14' high and 20' wide with four 1", three 3", and one 4" calipers. This shrub will be unaffected by the construction, however, should it be removed, mitigation value is four 24" box *Heteromeles arbutifolia*.
