TREE REPORT

9832 Wanda Park Dr.
Los Angeles, CA 90210

Prepared by
Harmony Gardens
12224 Addison St.
Valley Village, CA 91607
Phone 818-505-9783
Shelley Sparks, RLA # 2896, ASLA
ISA Certified Arborist #WE-10883A

16 September 2022

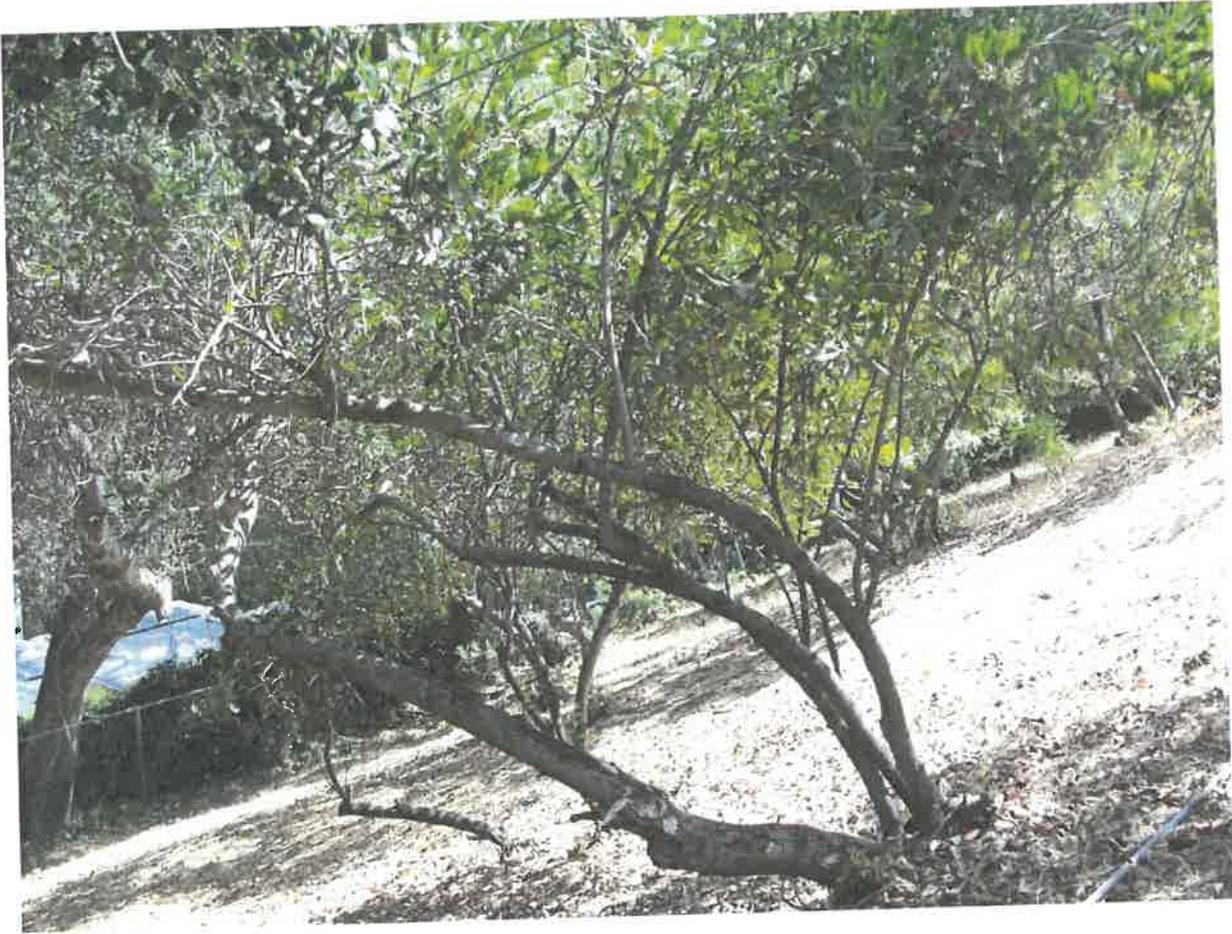
Shrub 21 is *Heteromeles arbutifolia*, Toyon, in poor condition with drought stress, dieback, and poor pruning. It is 16' high and 18' wide with eight 1", two 2", and three 3" calipers. This shrub will be unaffected by the construction, however, should it be removed, mitigation value is four 24" box *Heteromeles arbutifolia*.

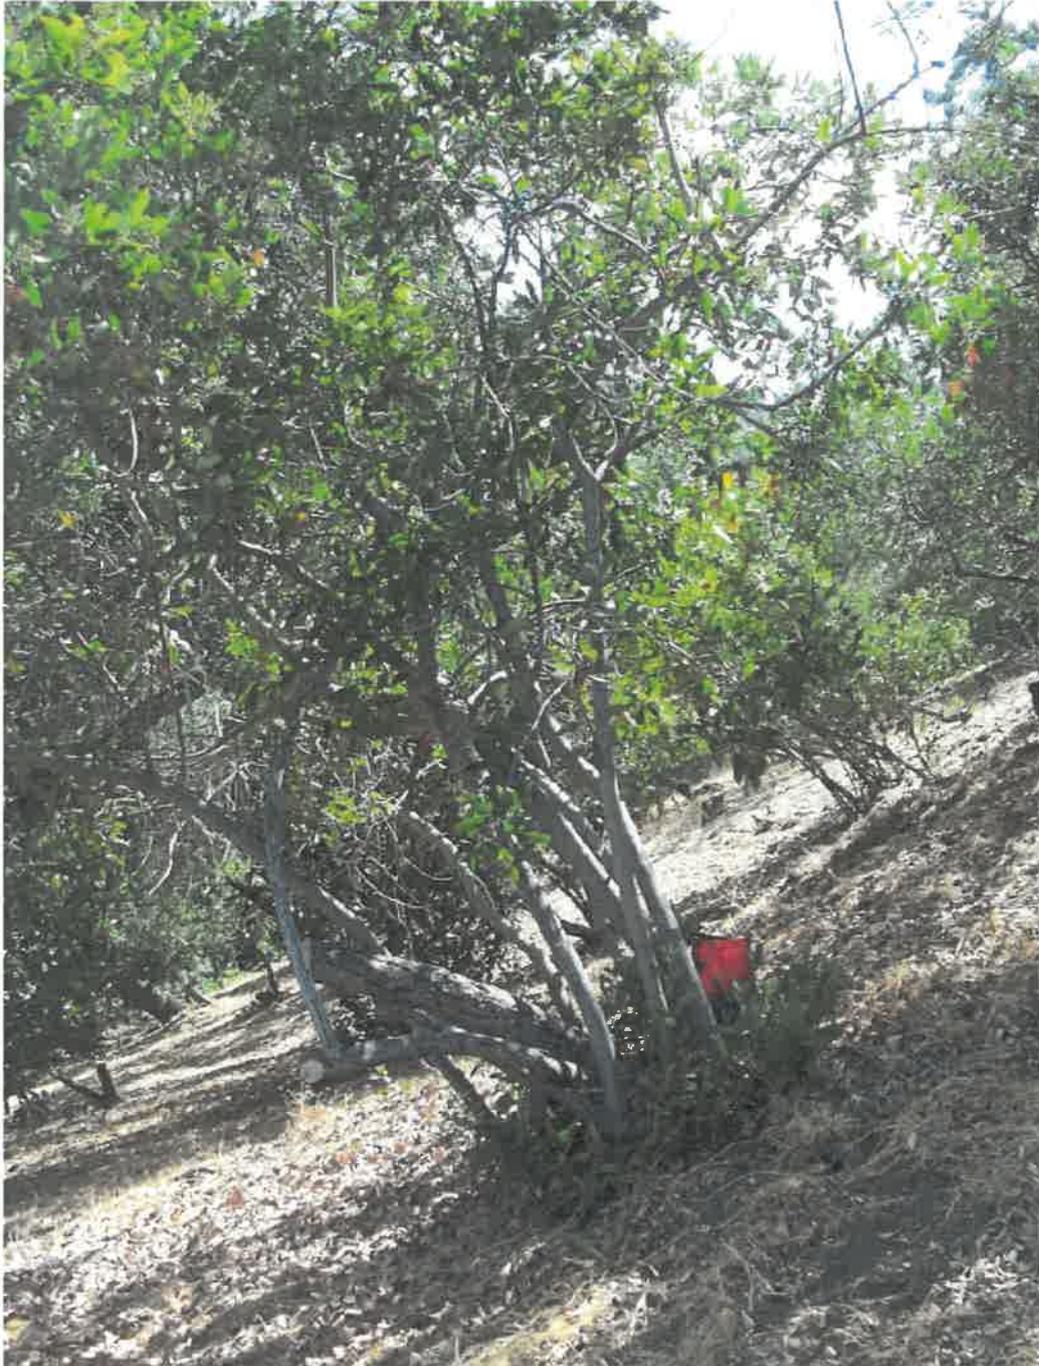
Shrub 22 is *Heteromeles arbutifolia*, Toyon, in fair condition with drought stress, dieback, and poor pruning. It is 12' high and 16' wide with two 2" and seven 3" calipers. This shrub will be unaffected by the construction, however, should it be removed, mitigation value is four 24" box *Heteromeles arbutifolia*.

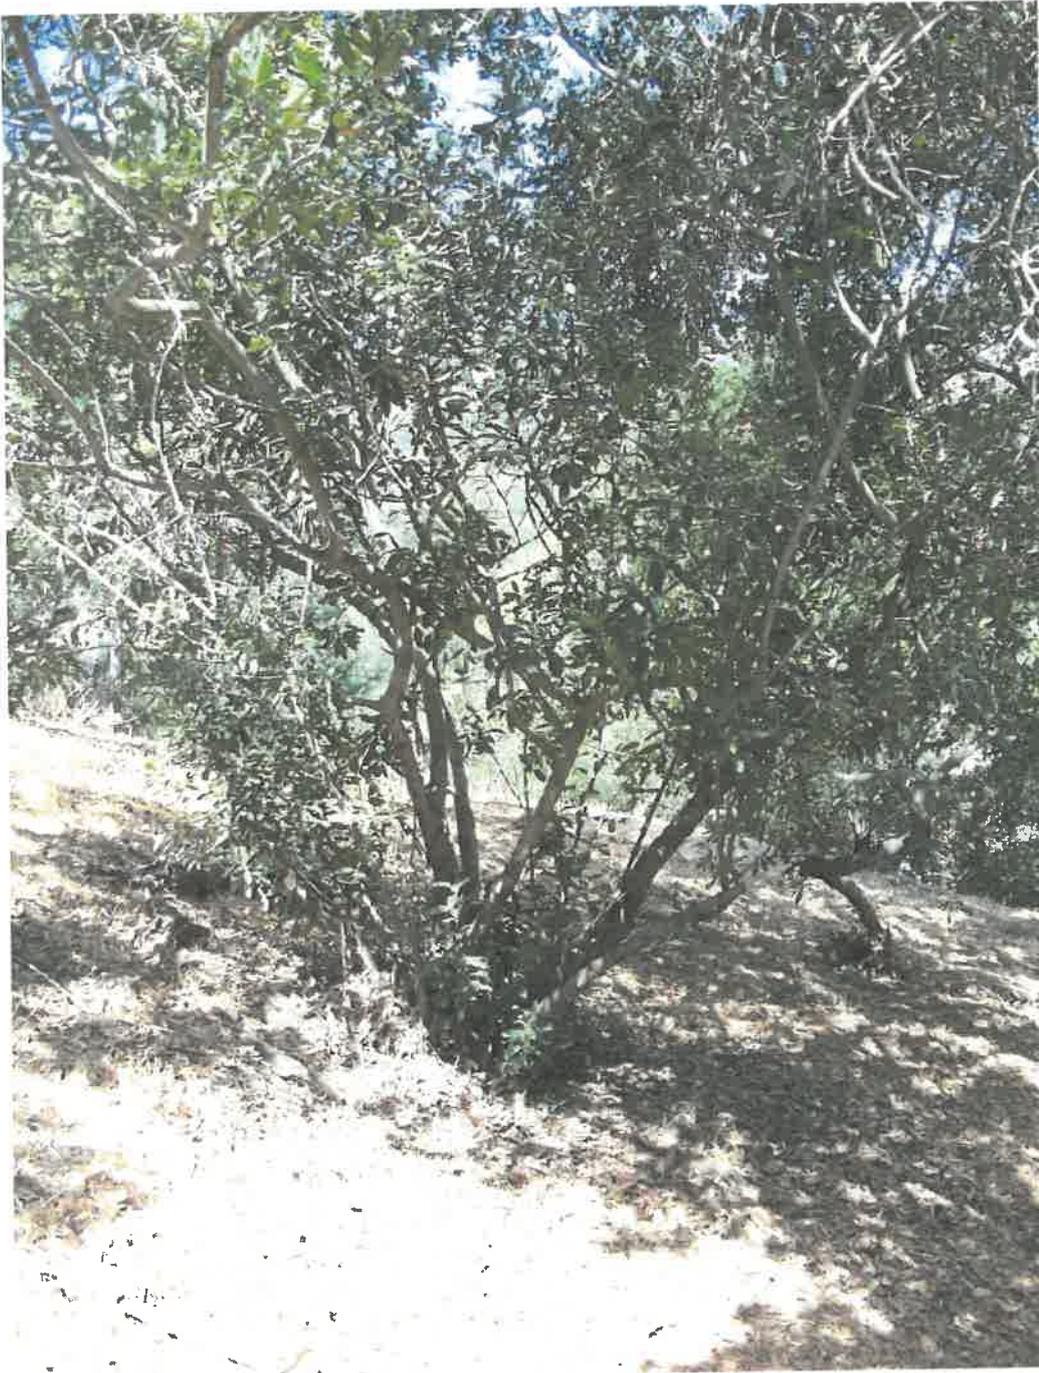
Shrub 23 is *Heteromeles arbutifolia*, Toyon, in fair condition with drought stress, dieback, and poor pruning. It is 12' high and 12' wide with six 1" and four 2" calipers. This shrub will be unaffected by the construction, however, should it be removed, mitigation value is four 24" box *Heteromeles arbutifolia*.

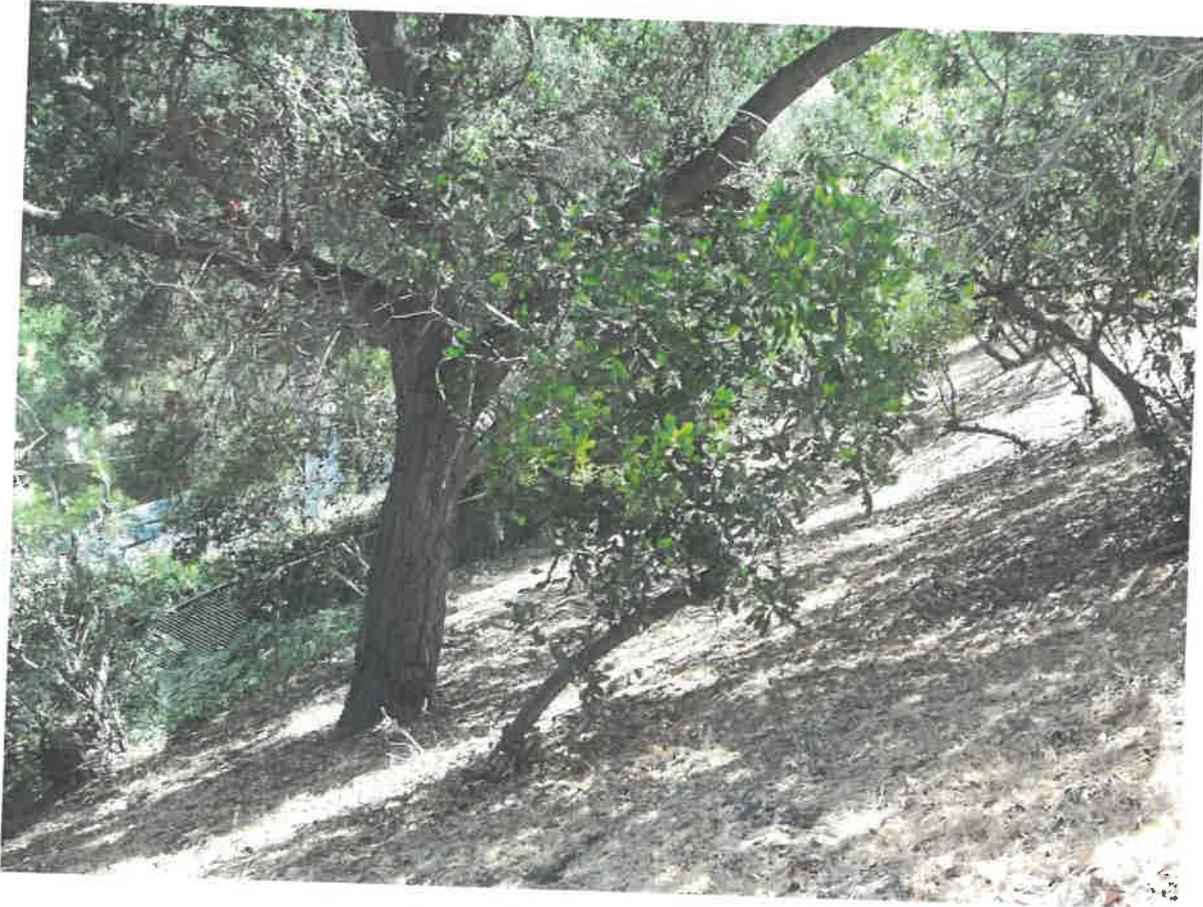
Shrub 24 is *Heteromeles arbutifolia*, Toyon, in fair condition with drought stress, dieback, and poor pruning. It is 8' high and 8' wide with a 4" caliper. This shrub will be unaffected by the construction, however, should it be removed, mitigation value is four 24" box *Heteromeles arbutifolia*.

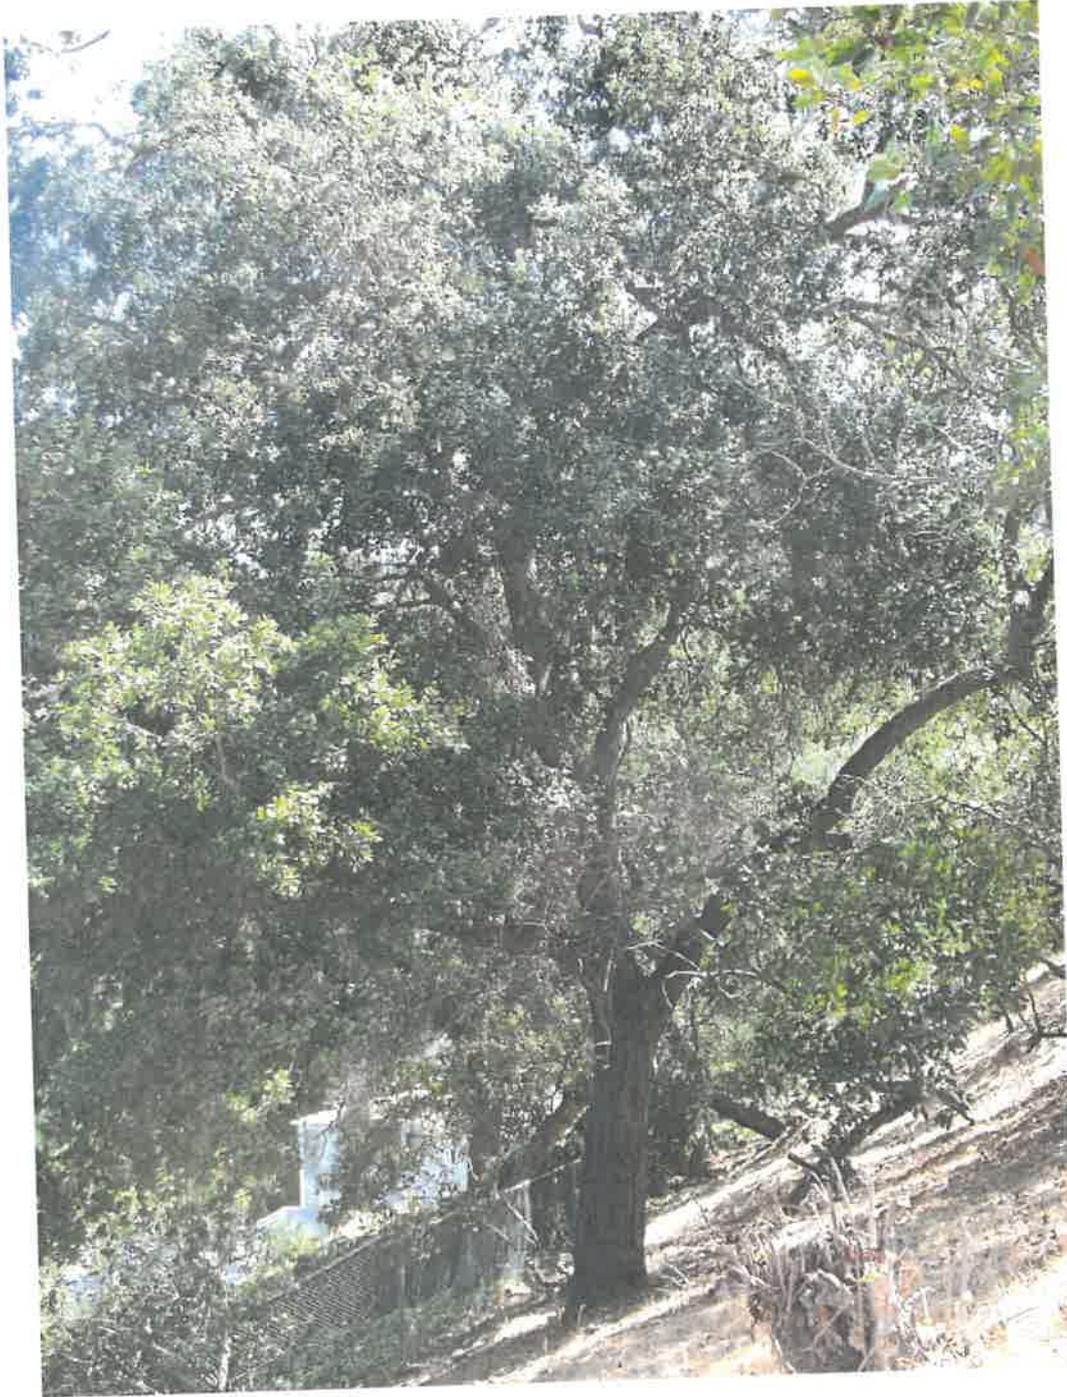
Tree 25 is *Quercus agrifolia*, Coast Live Oak, in good condition. It is 40' high and 40' wide with a 20" caliper. This tree will be unaffected by the construction, however, should it be removed, mitigation value is four 24"-box trees of the same variety, *Quercus agrifolia*.

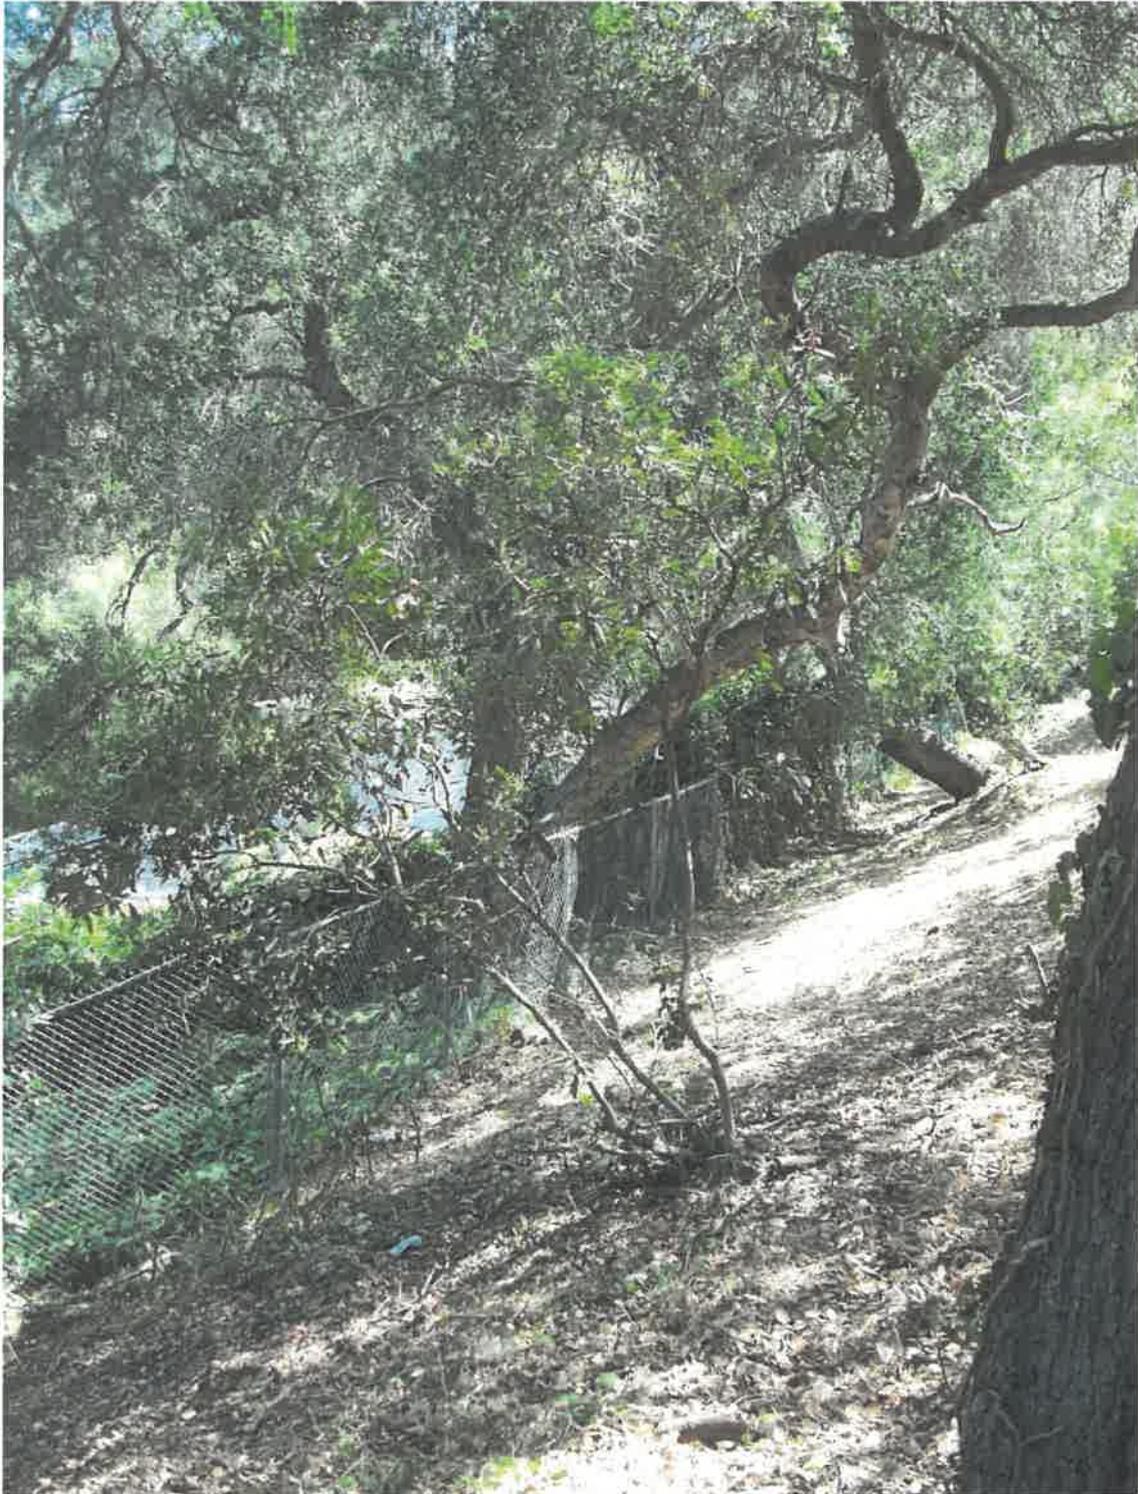
Shrub 26 is *Heteromeles arbutifolia*, Toyon, in fair condition with drought stress. It is 14' high and 12' wide with one 2" and one 3" calipers. This shrub will be unaffected by the construction, however, should it be removed, mitigation value is four 24" box *Heteromeles arbutifolia*.

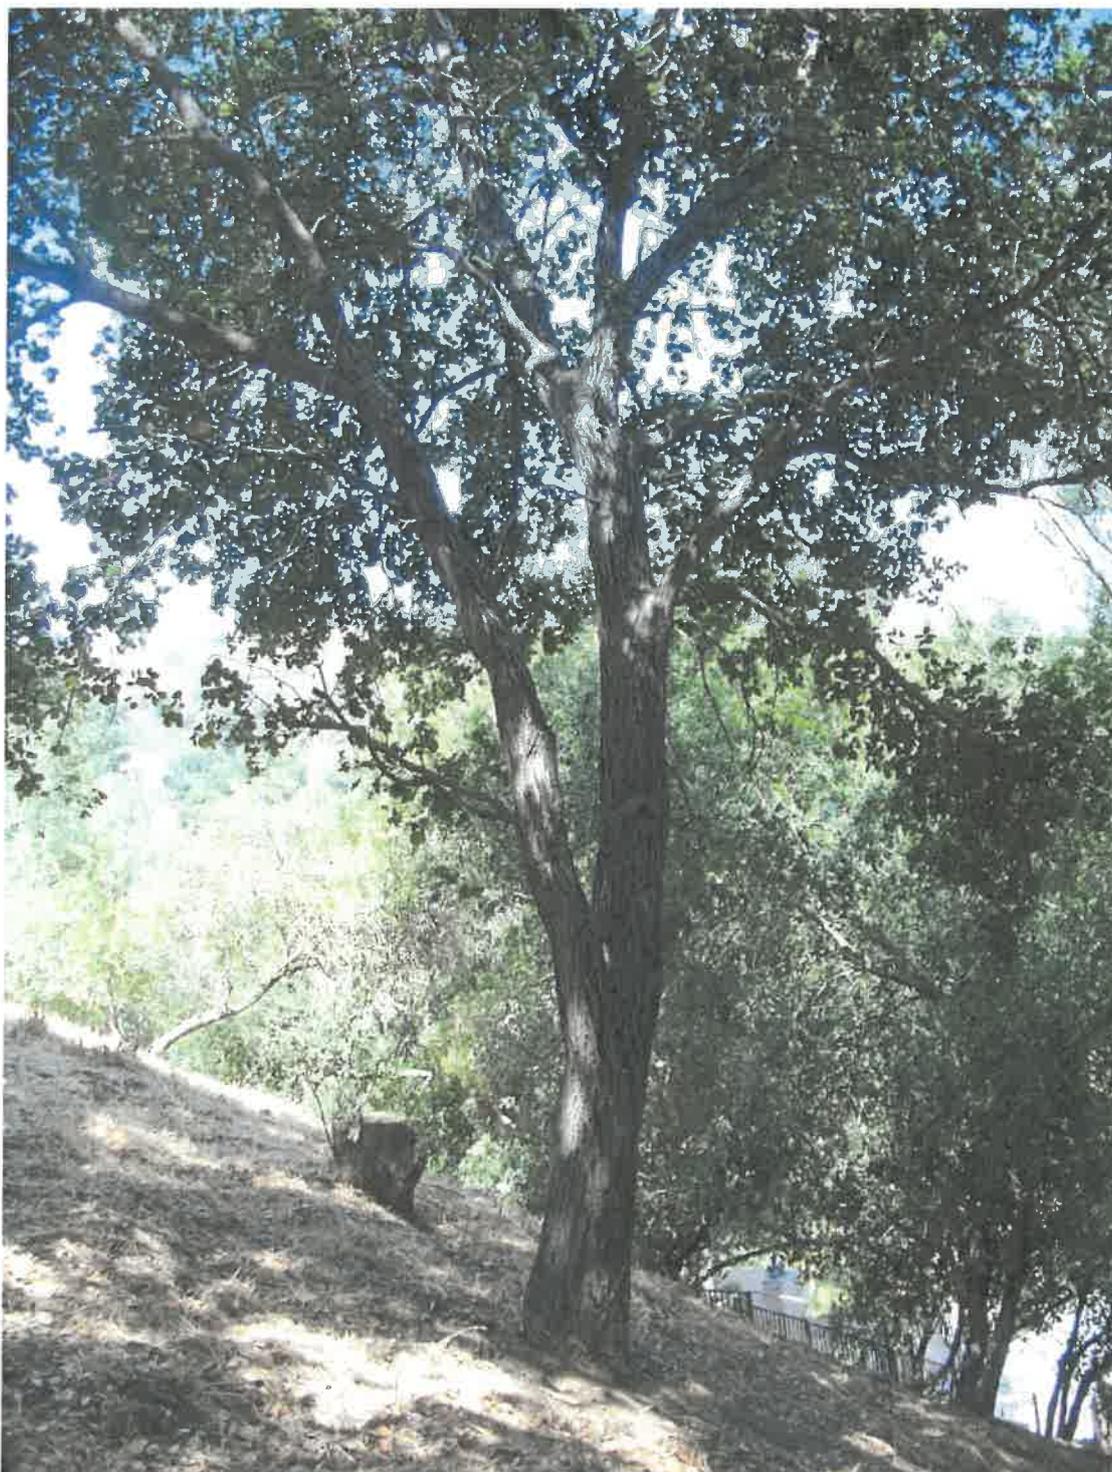
Tree 27 is *Quercus agrifolia*, Coast Live Oak, in good condition. It is 35' high and 28' wide with 8" and 11" calipers. This tree will be unaffected by the construction, however, should it be removed, mitigation value is four 24"-box trees of the same variety, *Quercus agrifolia*.

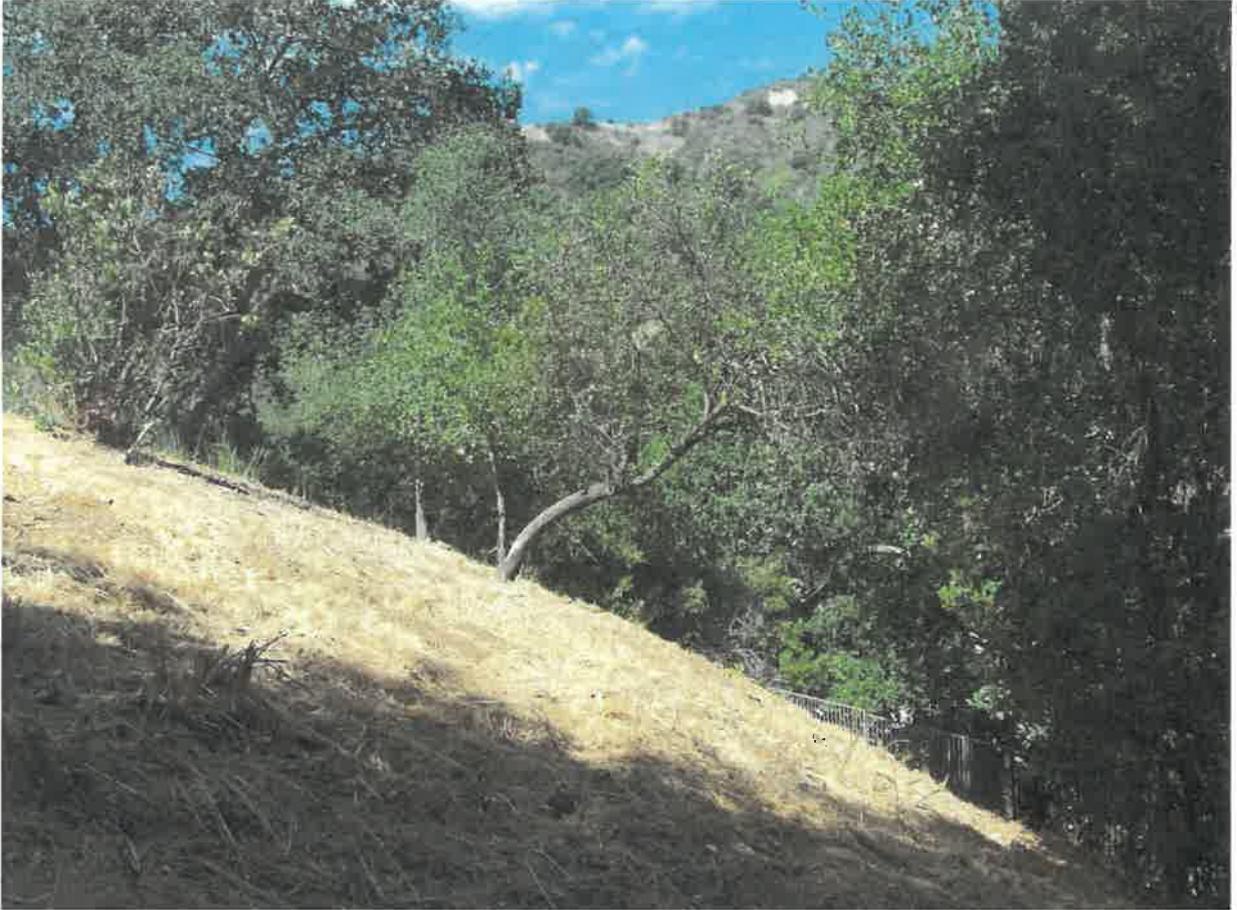
Tree 28 is *Quercus agrifolia*, Coast Live Oak, in fair condition with peeling bark and a leaning posture. It is 10' high and 8' wide with a 5" caliper. This tree will be unaffected by the construction, however, should it be removed, mitigation value is four 24"-box trees of the same variety, *Quercus agrifolia*.

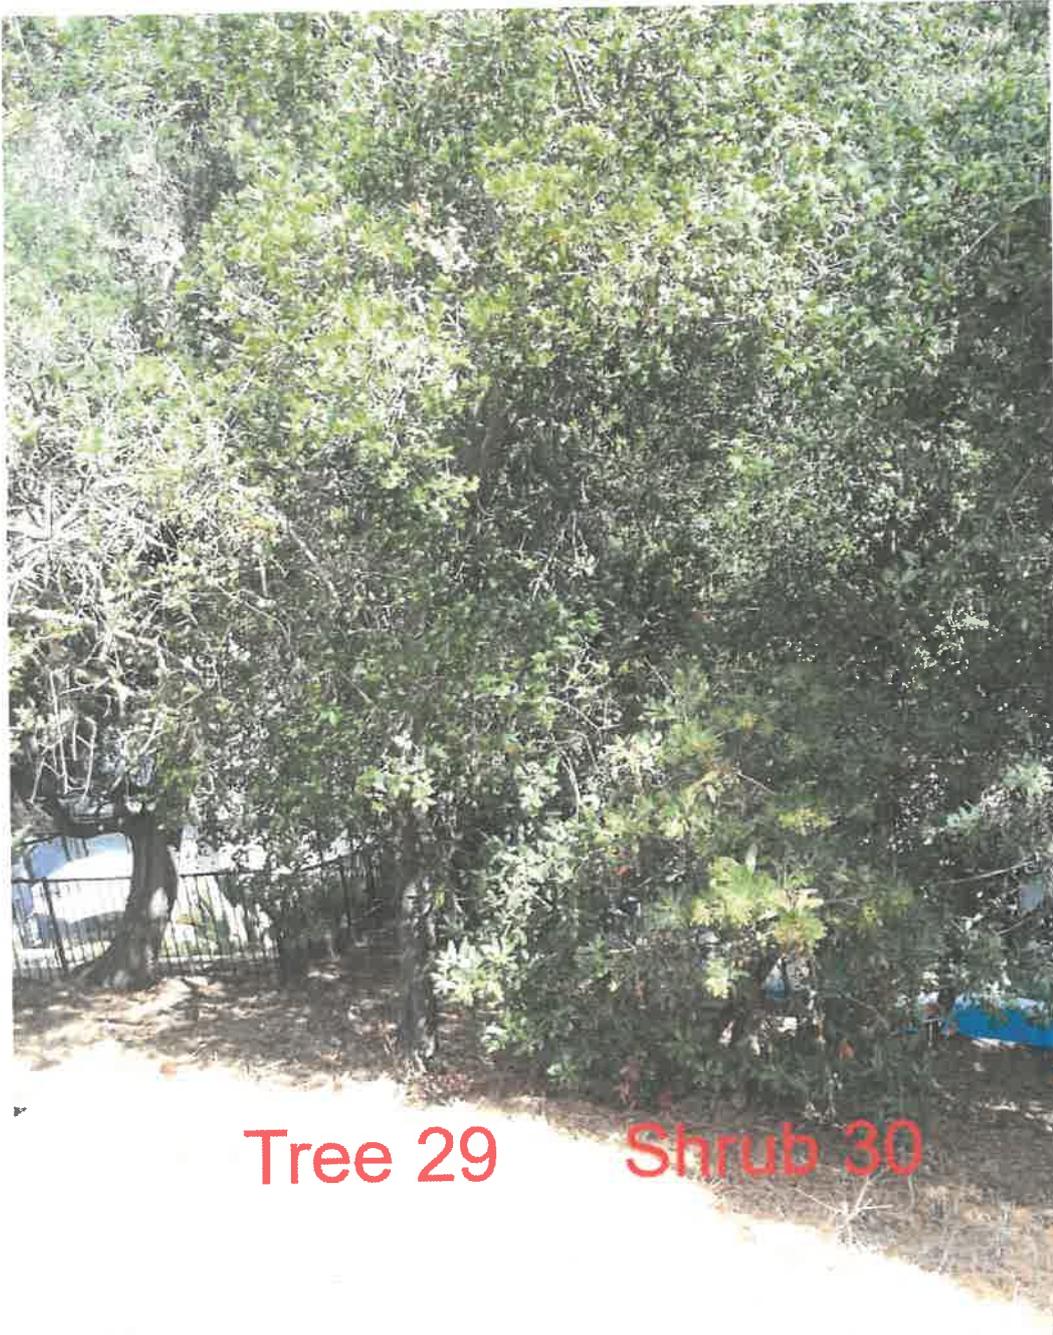
Tree 29 is *Quercus agrifolia*, Coast Live Oak, in good condition. It is 32' high and 24' wide with 2", 5" and 9" calipers. This tree will be unaffected by the construction, however, should it be removed, mitigation value is four 24"-box trees of the same variety, *Quercus agrifolia*.

Shrub 30 is *Heteromeles arbutifolia*, Toyon, in fair condition with poor pruning. It is 8' high and 8' wide with one 1", two 2", and one 3" calipers. This shrub will be unaffected by the construction, however, should it be removed, mitigation value is four 24" box *Heteromeles arbutifolia*.

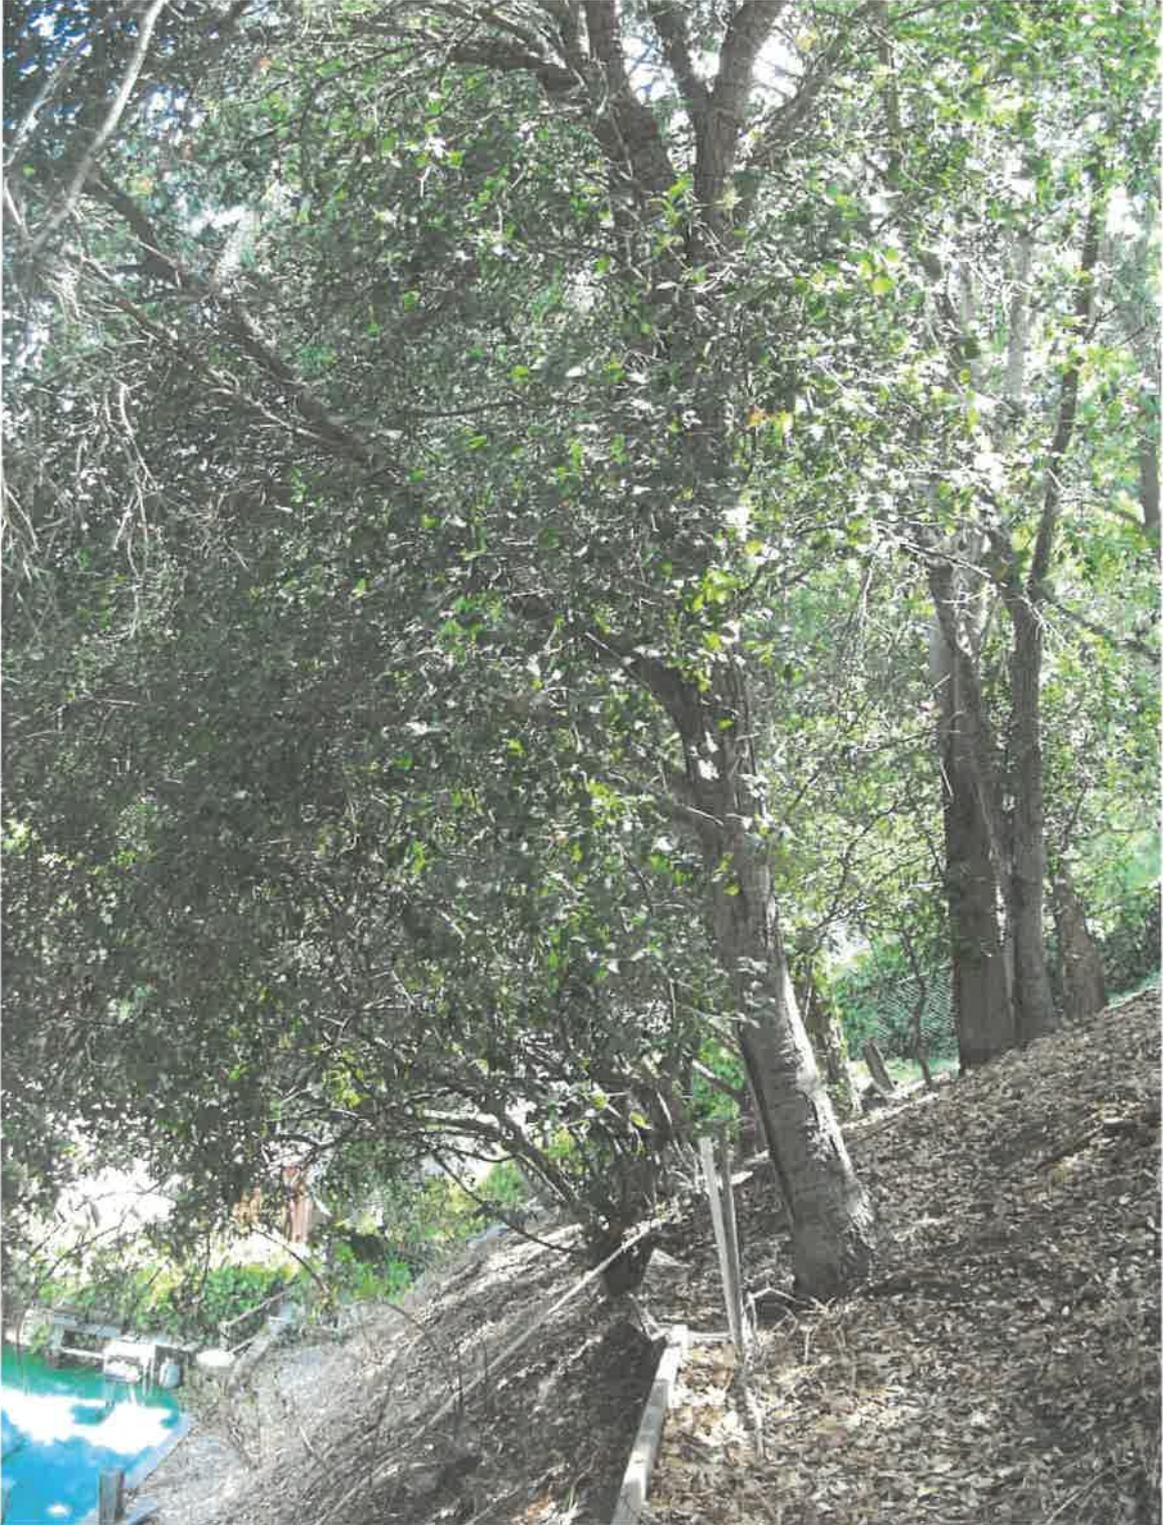
Tree 31 is *Quercus agrifolia*, Coast Live Oak, in fair condition with drought stress, dieback, and leaning posture. It is 20' high and 18' wide with an 8" caliper. This tree will be unaffected by the construction, however, should it be removed, mitigation value is four 24"-box trees of the same variety, *Quercus agrifolia*.

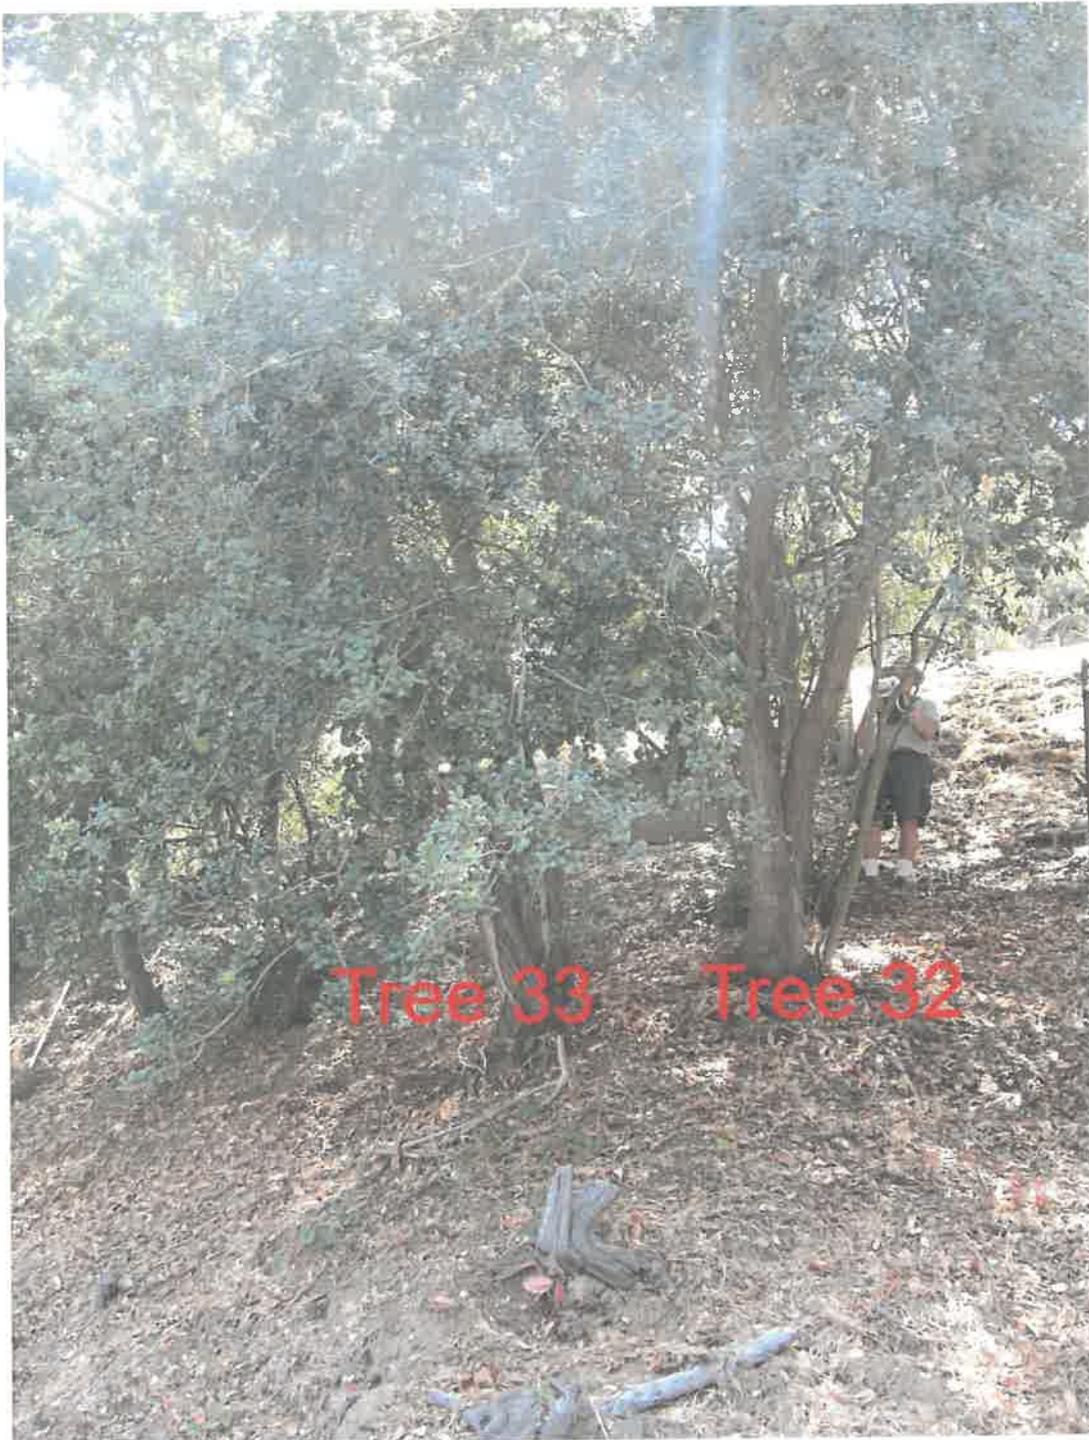
Tree 32 is *Quercus agrifolia*, Coast Live Oak, in good condition. It is 33' high and 25' wide with 7" and 8" calipers. This tree will be unaffected by the construction, however, should it be removed, mitigation value is four 24"-box trees of the same variety, *Quercus agrifolia*.

Tree 33 is *Quercus agrifolia*, Coast Live Oak, in good condition. It is 26' high and 16' wide with 6" and 7" calipers. This tree will be unaffected by the construction, however, should it be removed, mitigation value is four 24"-box trees of the same variety, *Quercus agrifolia*.

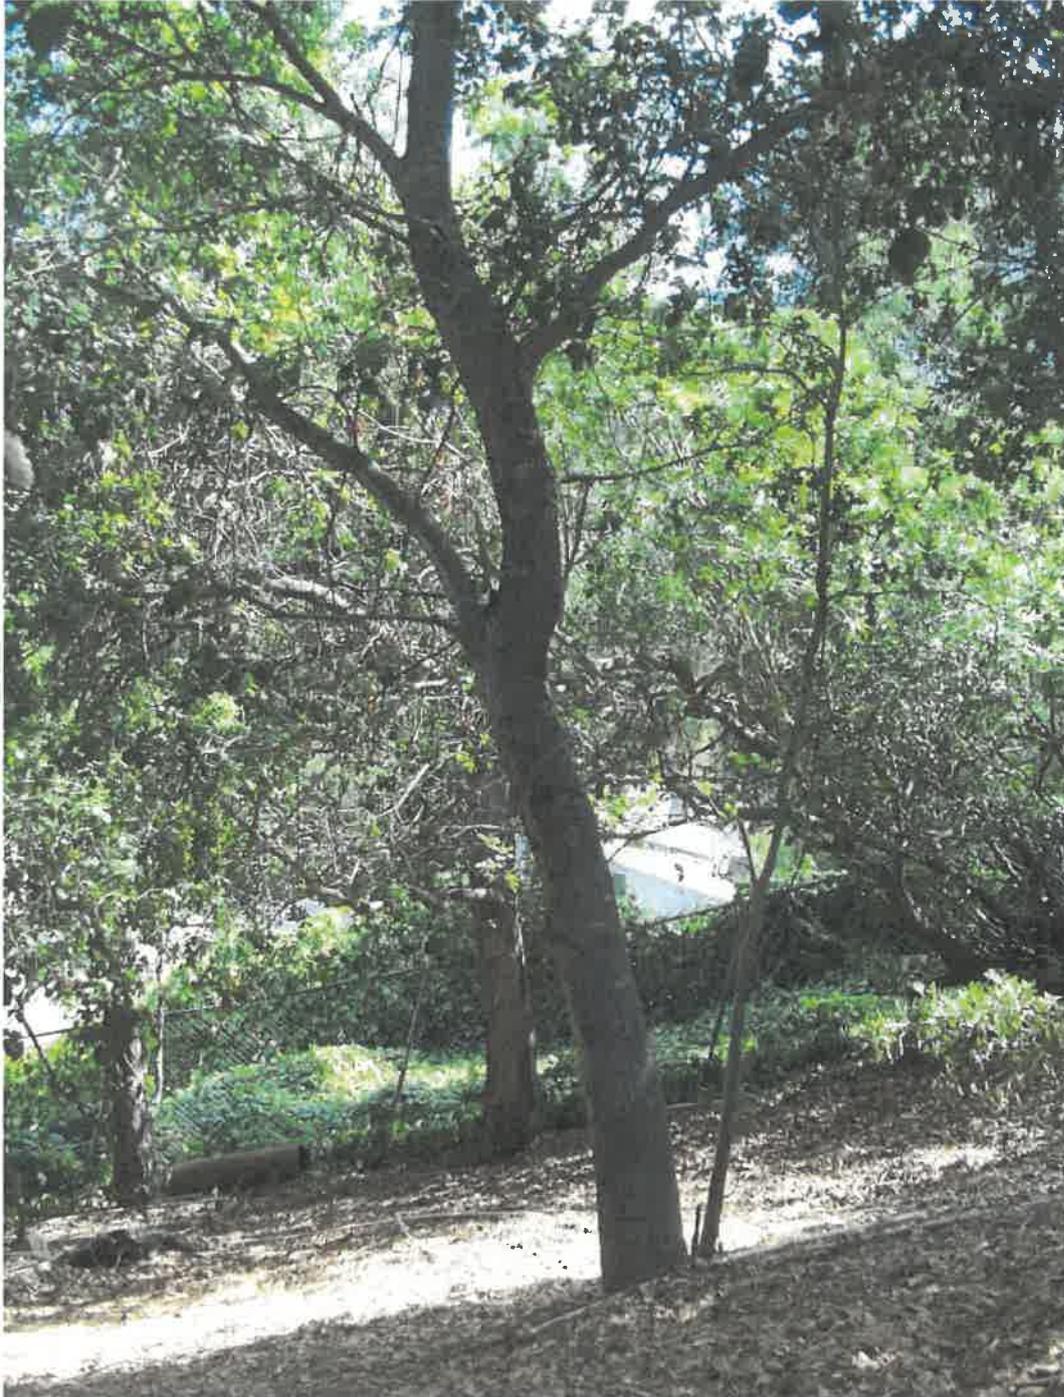
Tree 34 is *Fraxinus pennsylvanica*, Swamp Ash, in good condition with some peeling bark. It is 40' high and 30' wide with a 12" caliper. This tree will be unaffected by the construction, however, should it be removed, mitigation value is one 24"-box tree.

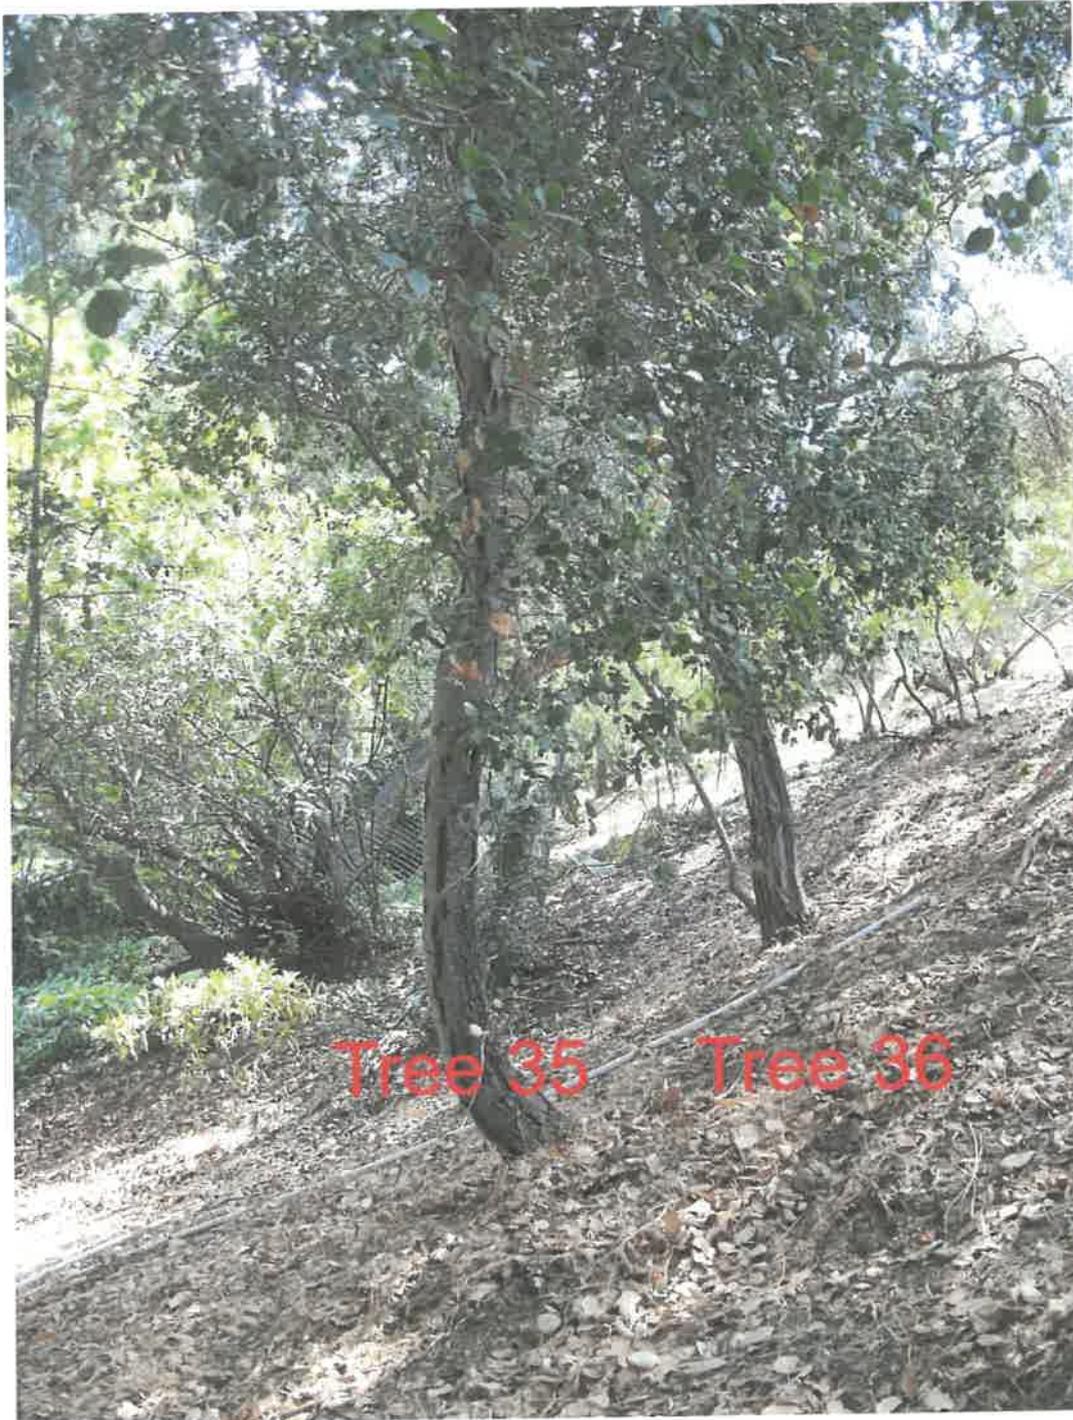
Tree 35 is *Quercus agrifolia*, Coast Live Oak, in good condition. It is 37' high and 25' wide with a 9" caliper. This tree will be unaffected by the construction, however, should it be removed, mitigation value is four 24"-box trees of the same variety, *Quercus agrifolia*.

Tree 36 is *Quercus agrifolia*, Coast Live Oak, in good condition. It is 22' high and 11' wide with a 5" caliper. This tree will be unaffected by the construction, however, should it be removed, mitigation value is four 24"-box trees of the same variety, *Quercus agrifolia*.

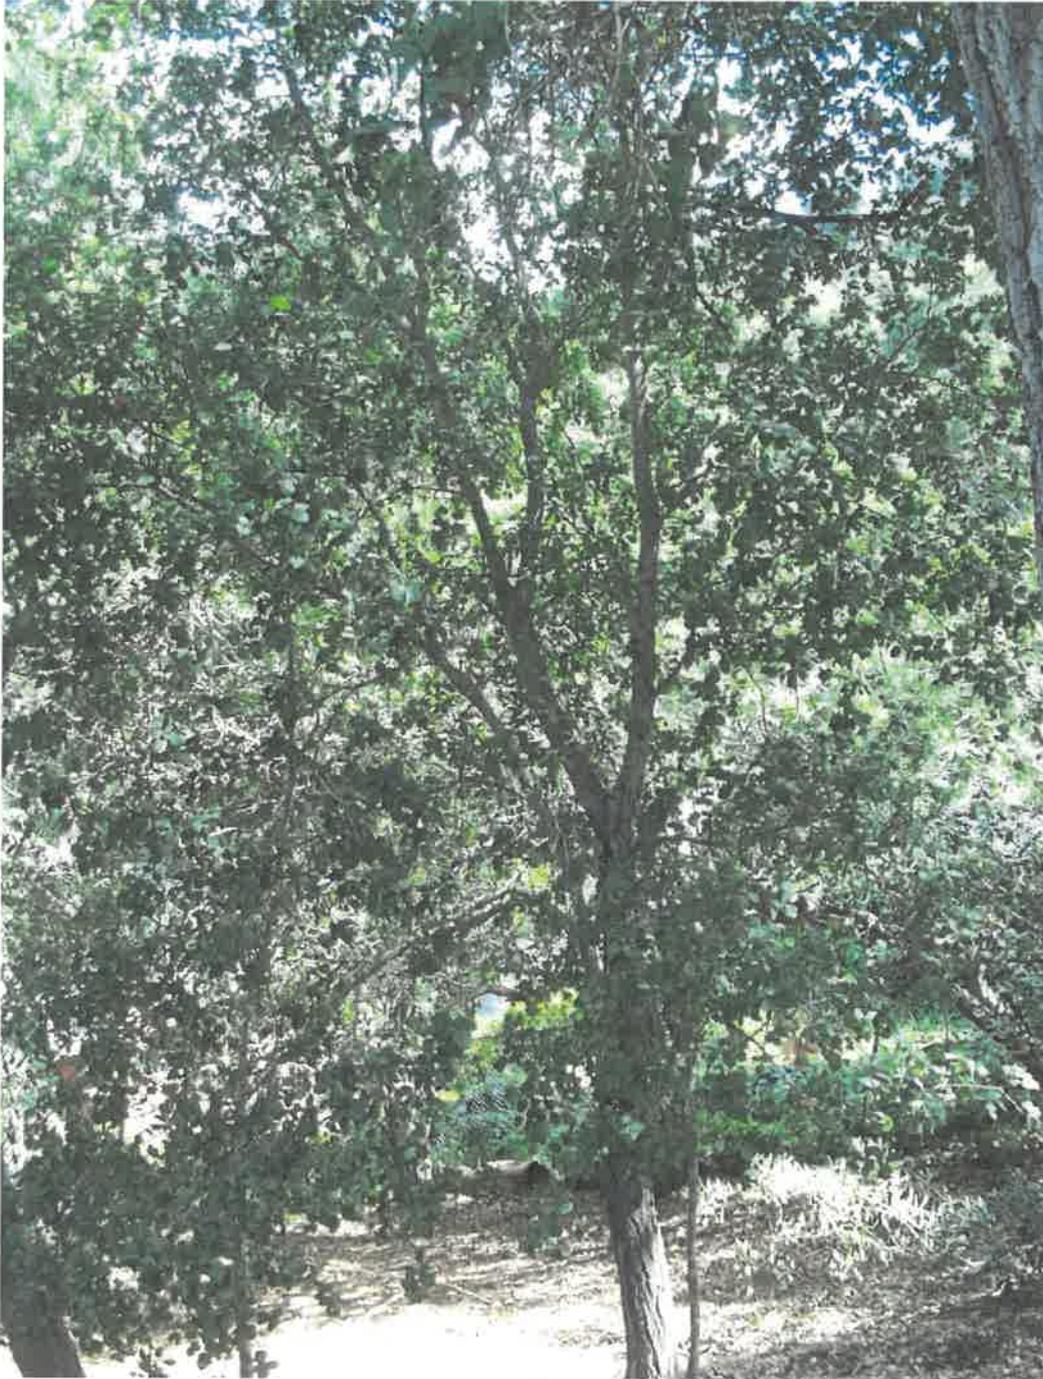
Tree 37 is *Quercus agrifolia*, Coast Live Oak, in good condition. It is 24' high and 12' wide with 1" and 7" calipers. This tree will be unaffected by the construction, however, should it be removed, mitigation value is four 24"-box trees of the same variety, *Quercus agrifolia*.

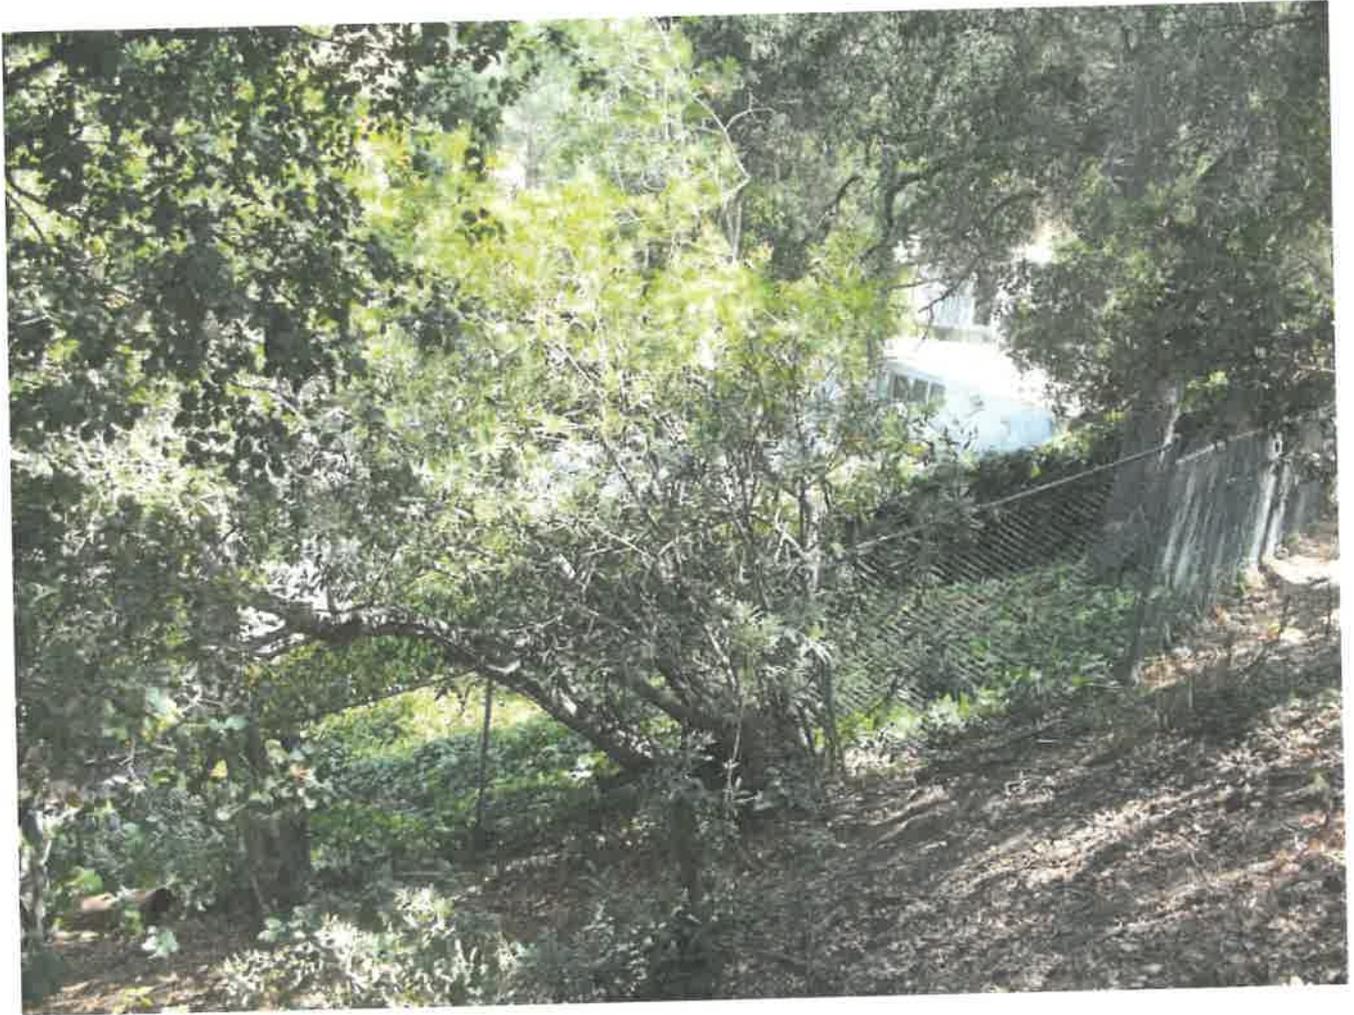
Shrub 38 is *Heteromeles arbutifolia*, Toyon, in poor condition with dieback, and poor pruning. It is 20' high and 28' wide with seven 1", two 2", and 4", 5", and 6" calipers. This shrub will be unaffected by the construction, however, should it be removed, mitigation value is four 24" box *Heteromeles arbutifolia*.
