TREE REPORT

9832 Wanda Park Dr.
Los Angeles, CA 90210

Prepared by
Harmony Gardens
12224 Addison St.
Valley Village, CA 91607
Phone 818-505-9783
Shelley Sparks, RLA # 2896, ASLA
ISA Certified Arborist #WE-10883A

16 September 2022

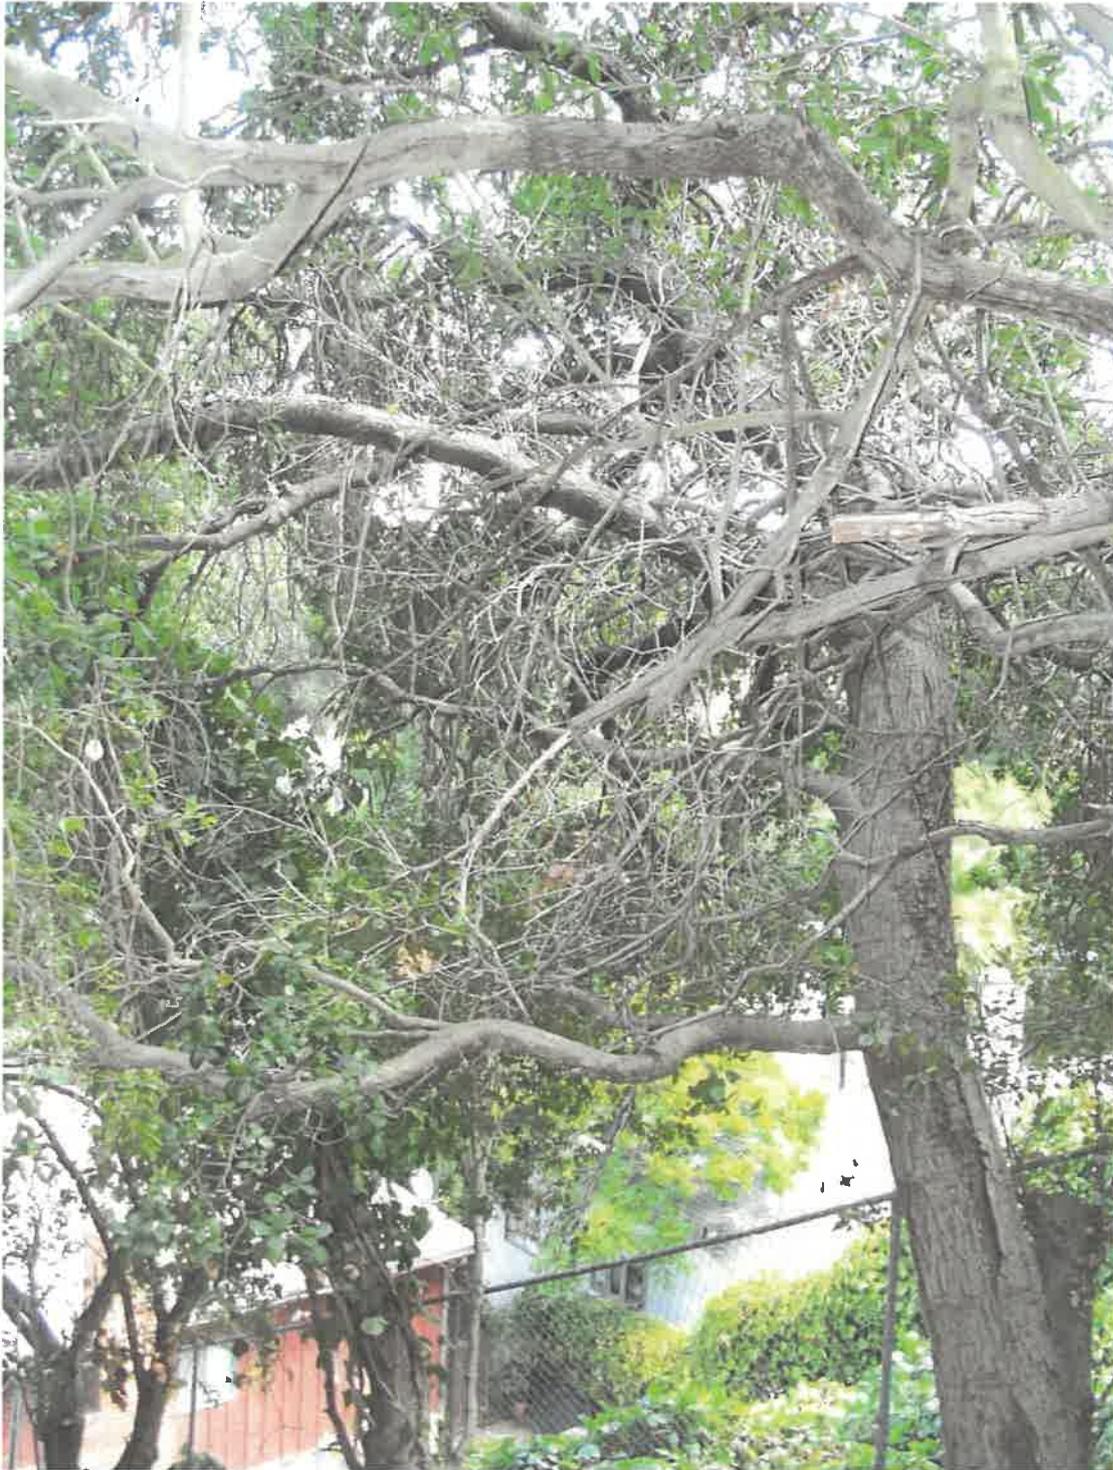
Tree 39 is *Quercus agrifolia*, Coast Live Oak, in poor condition with dieback and poor pruning. It is 30' high and 24' wide with a 13" caliper. This tree will be unaffected by the construction, however, should it be removed, mitigation value is four 24"-box trees of the same variety, *Quercus agrifolia*.

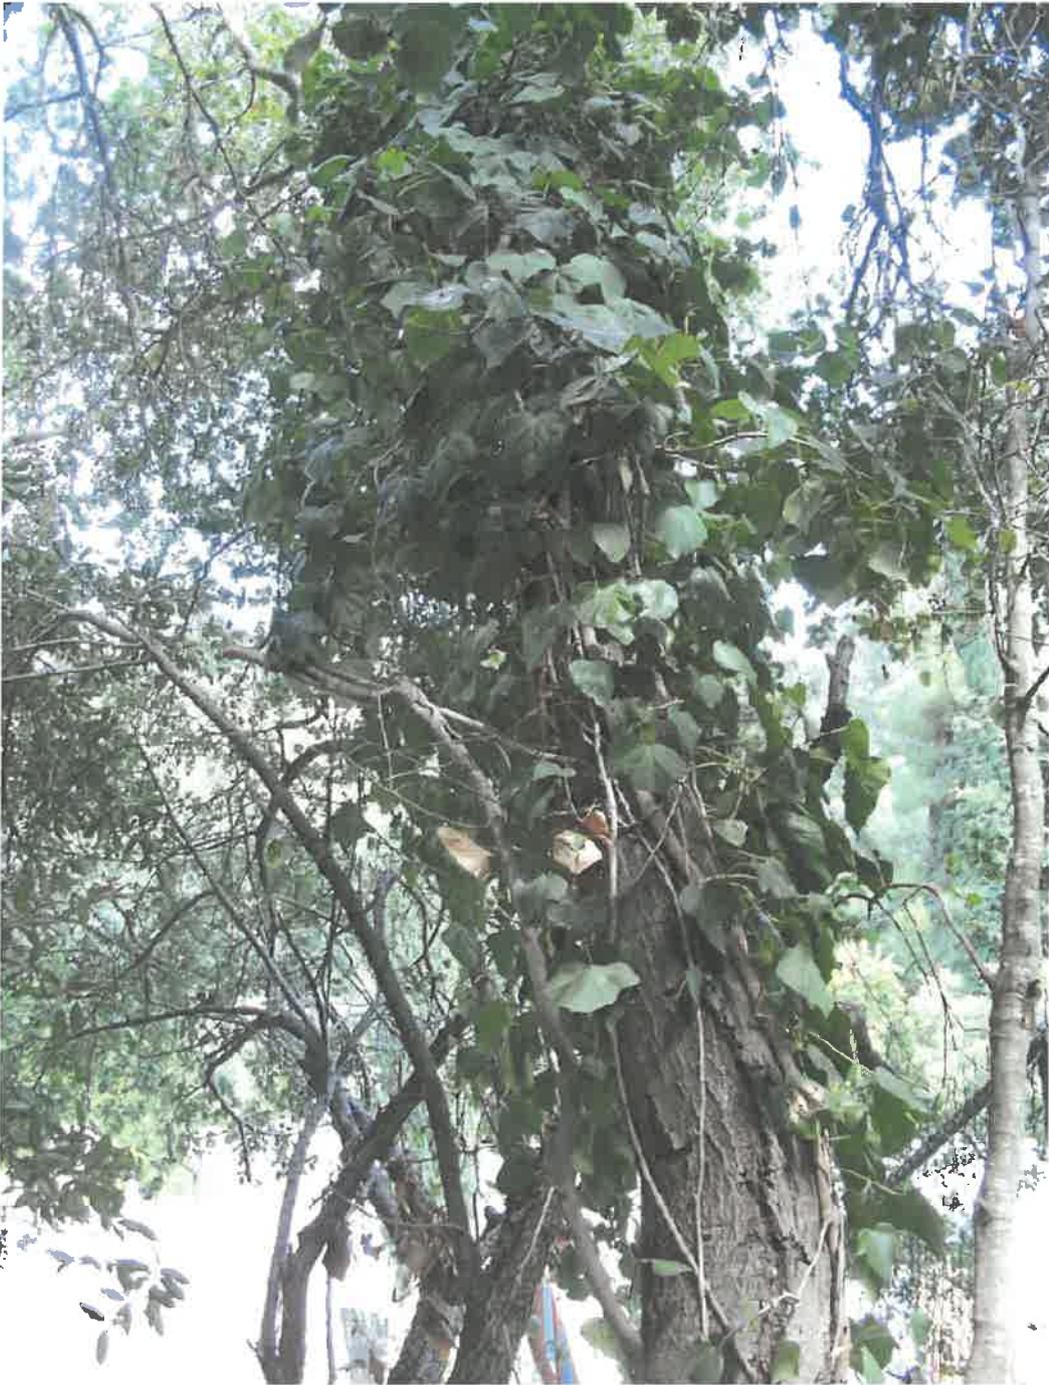
Tree 40 is *Quercus agrifolia*, Coast Live Oak, in fair condition, ivy-choked, with some dieback and poor pruning. It is 32' high and 20' wide with a 1", two 2", and 11" calipers. This tree will be unaffected by the construction, however, should it be removed, mitigation value is four 24"-box trees of the same variety, *Quercus agrifolia*.

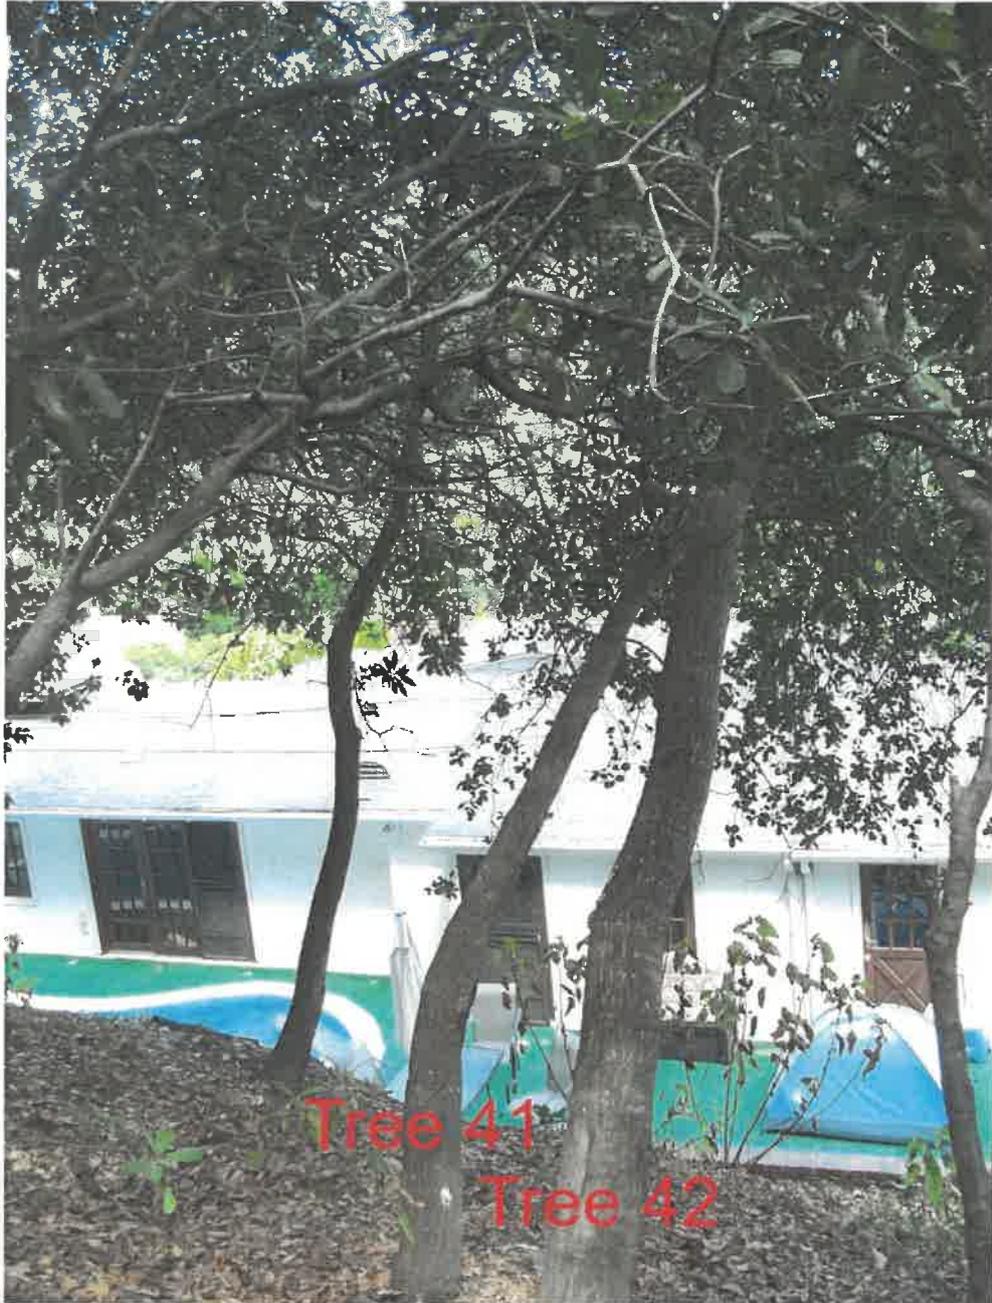
Tree 41 is *Quercus agrifolia*, Coast Live Oak, in good condition with a leaning posture and poor pruning. It is 21' high and 12' wide with a 7" caliper. This tree should be protected in place during construction; should it be removed, mitigation value is four 24"-box trees of the same variety, *Quercus agrifolia*.

Tree 42 is *Quercus agrifolia*, Coast Live Oak, in good condition with a leaning posture and poor pruning. It is 17' high and 8' wide with a 5" caliper. This tree should be protected in place during construction; should it be removed, mitigation value is four 24"-box trees of the same variety, *Quercus agrifolia*.

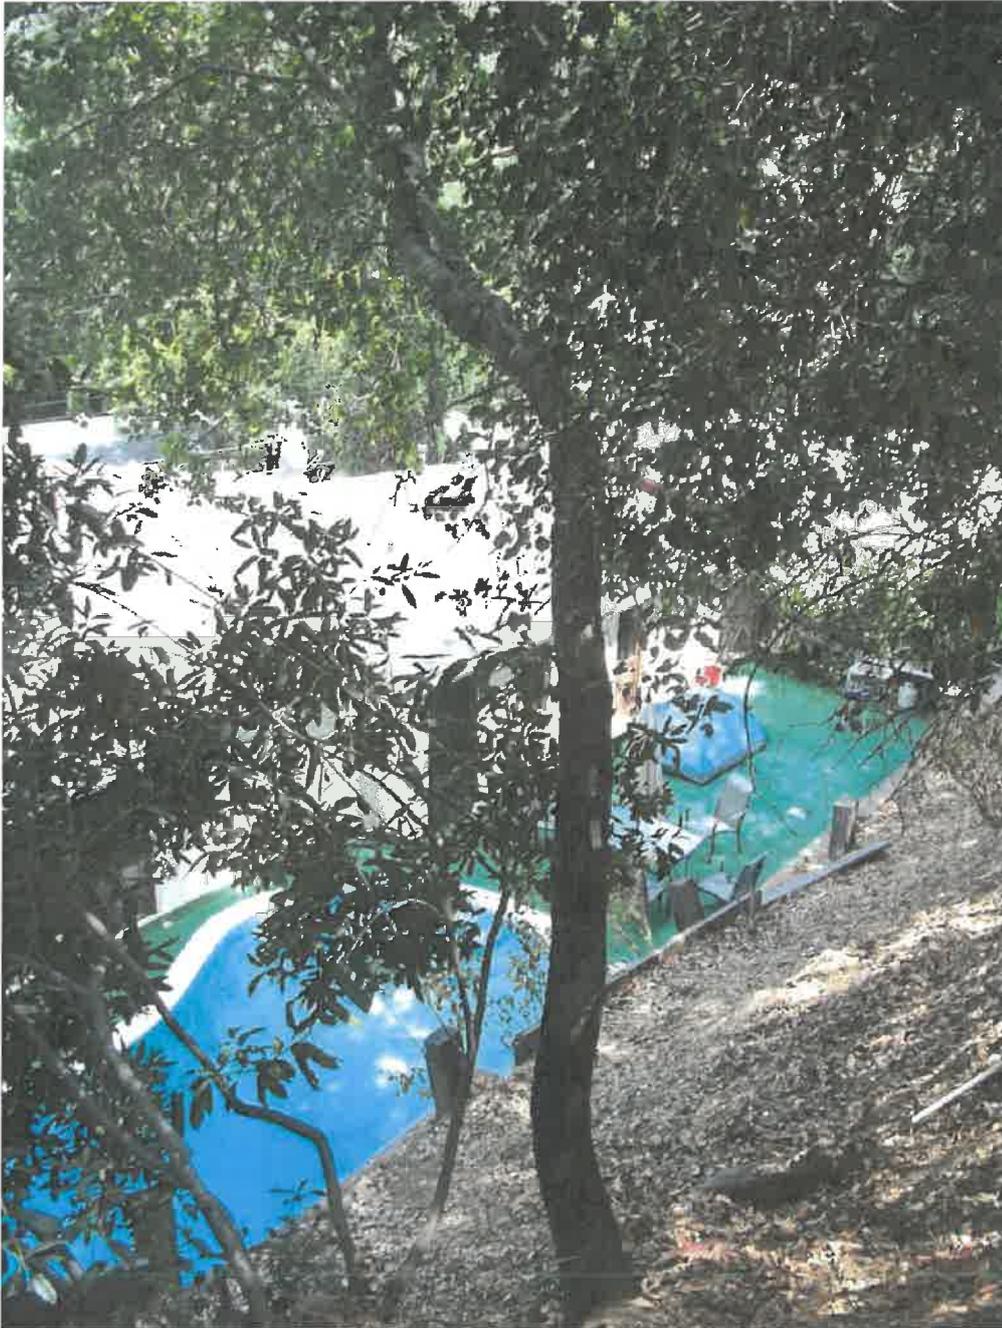
Tree 43 is *Quercus agrifolia*, Coast Live Oak, in good condition with a leaning posture and poor pruning. It is 17' high and 10' wide with a 4" caliper. This tree should be protected in place during construction; should it be removed, mitigation value is four 24"-box trees of the same variety, *Quercus agrifolia*.

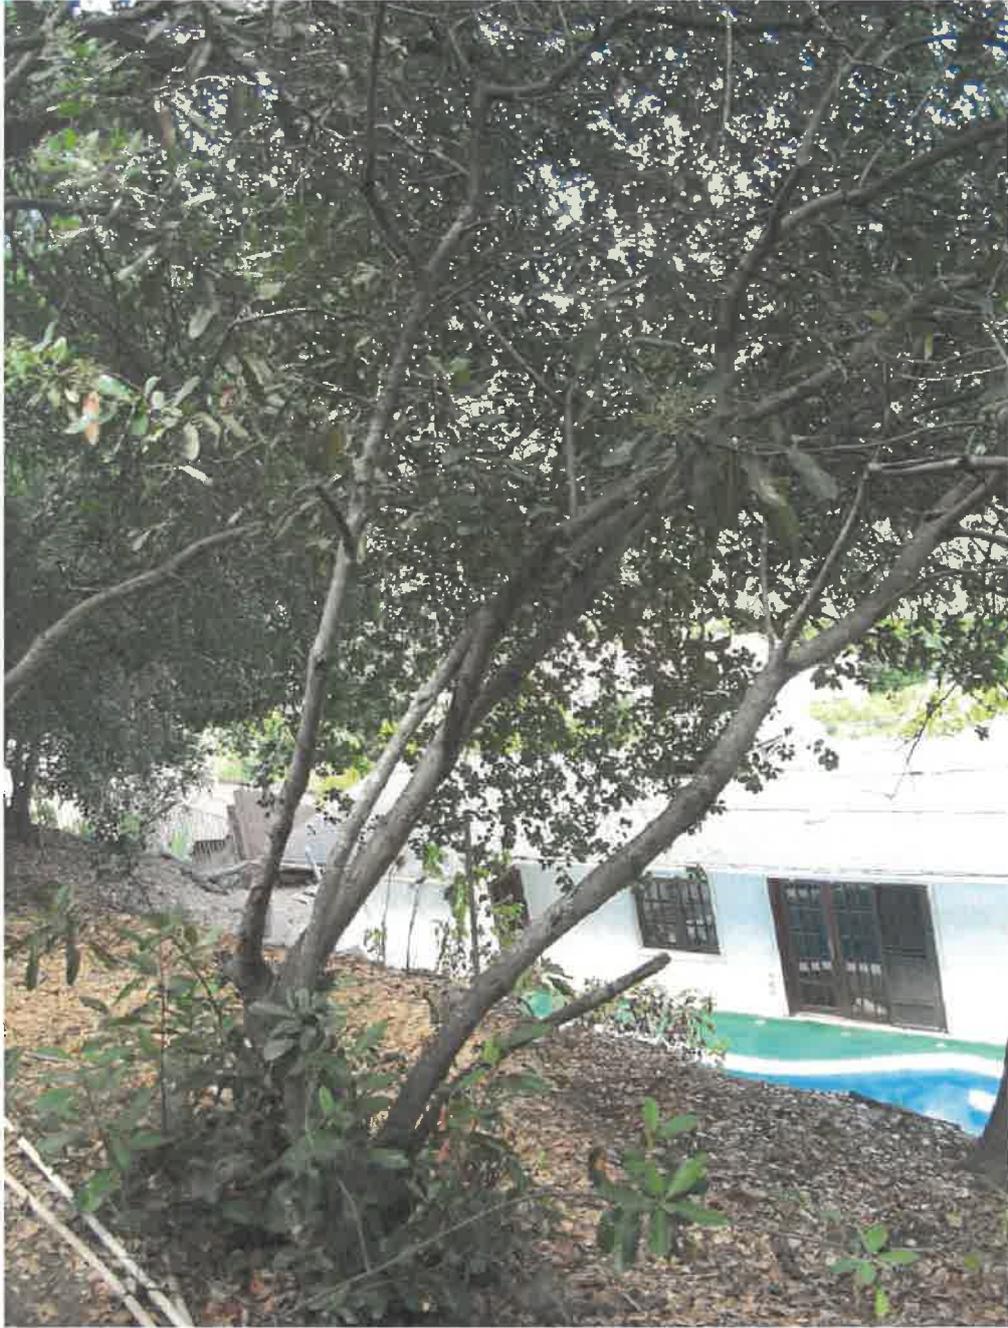
Shrub 44 is *Heteromeles arbutifolia*, Toyon, in good condition with some dieback and poor pruning. It is 13' high and 12' wide with four 2" and one 3" calipers. This shrub should be protected in place during construction; should it be removed, mitigation value is four 24" box *Heteromeles arbutifolia*.

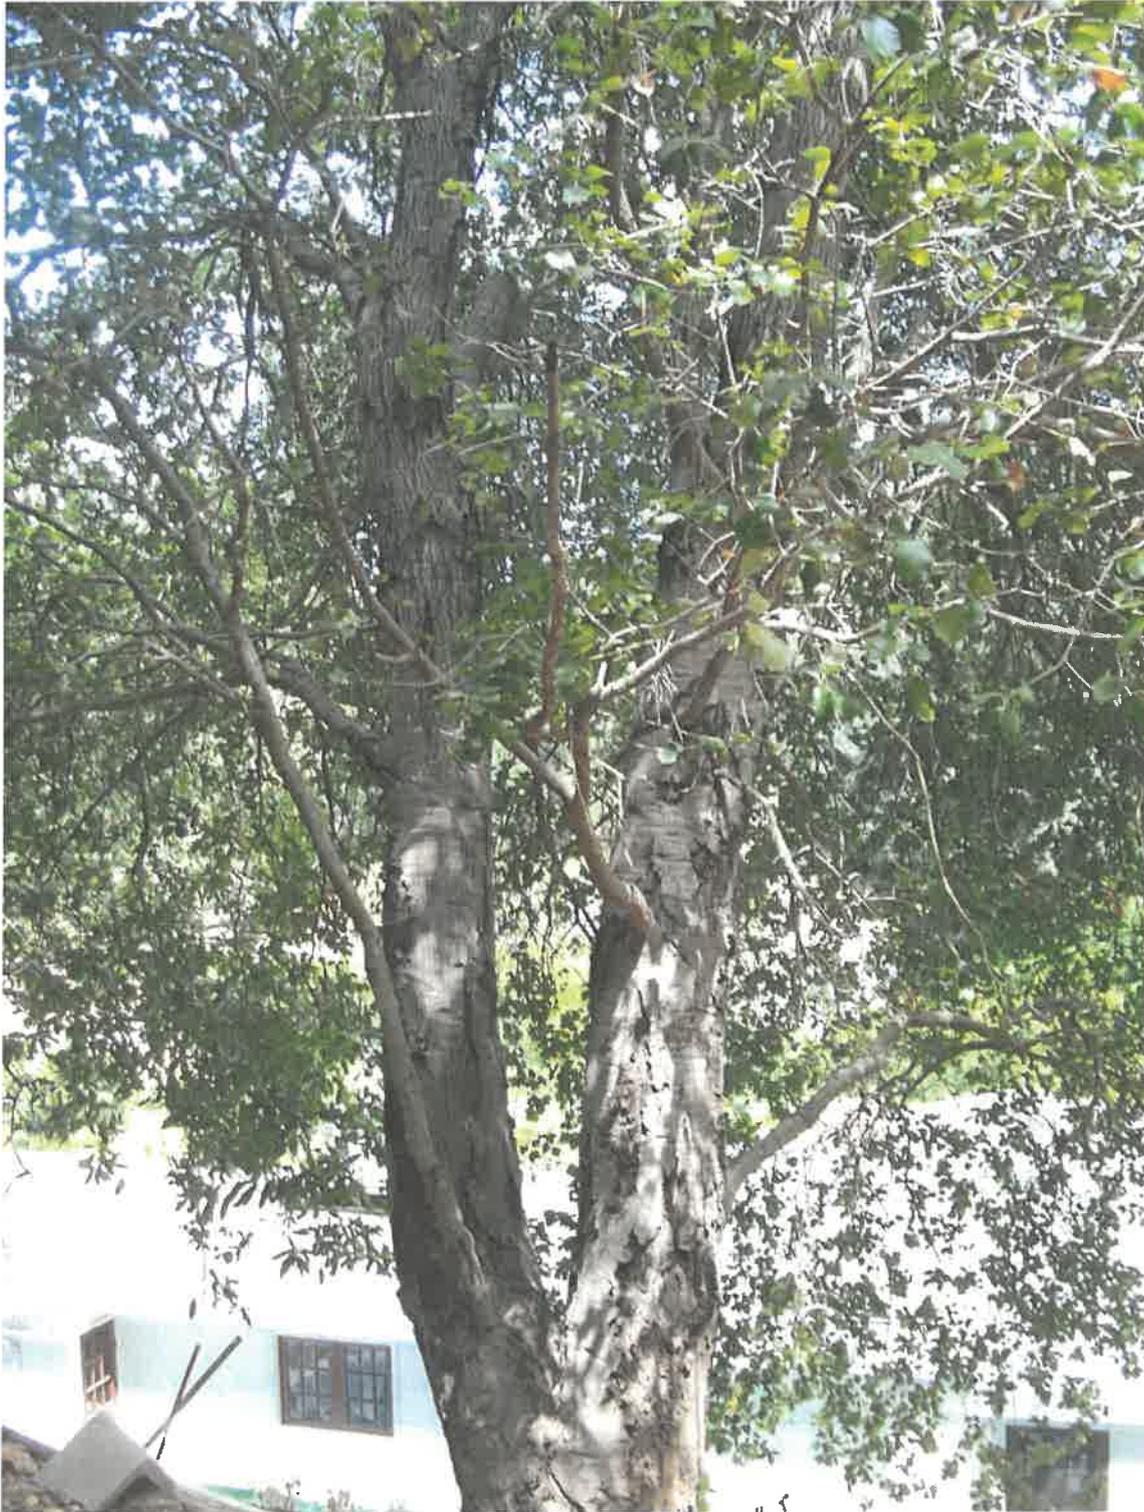
Tree 45 is *Quercus agrifolia*, Coast Live Oak, in good condition with co-dominant trunks, some dieback, and poor pruning. It is 42' high and 36' wide with 2", 3", 12", and 13" calipers. This tree should be unaffected during construction; should it be removed, mitigation value is four 24"-box trees of the same variety, *Quercus agrifolia*.

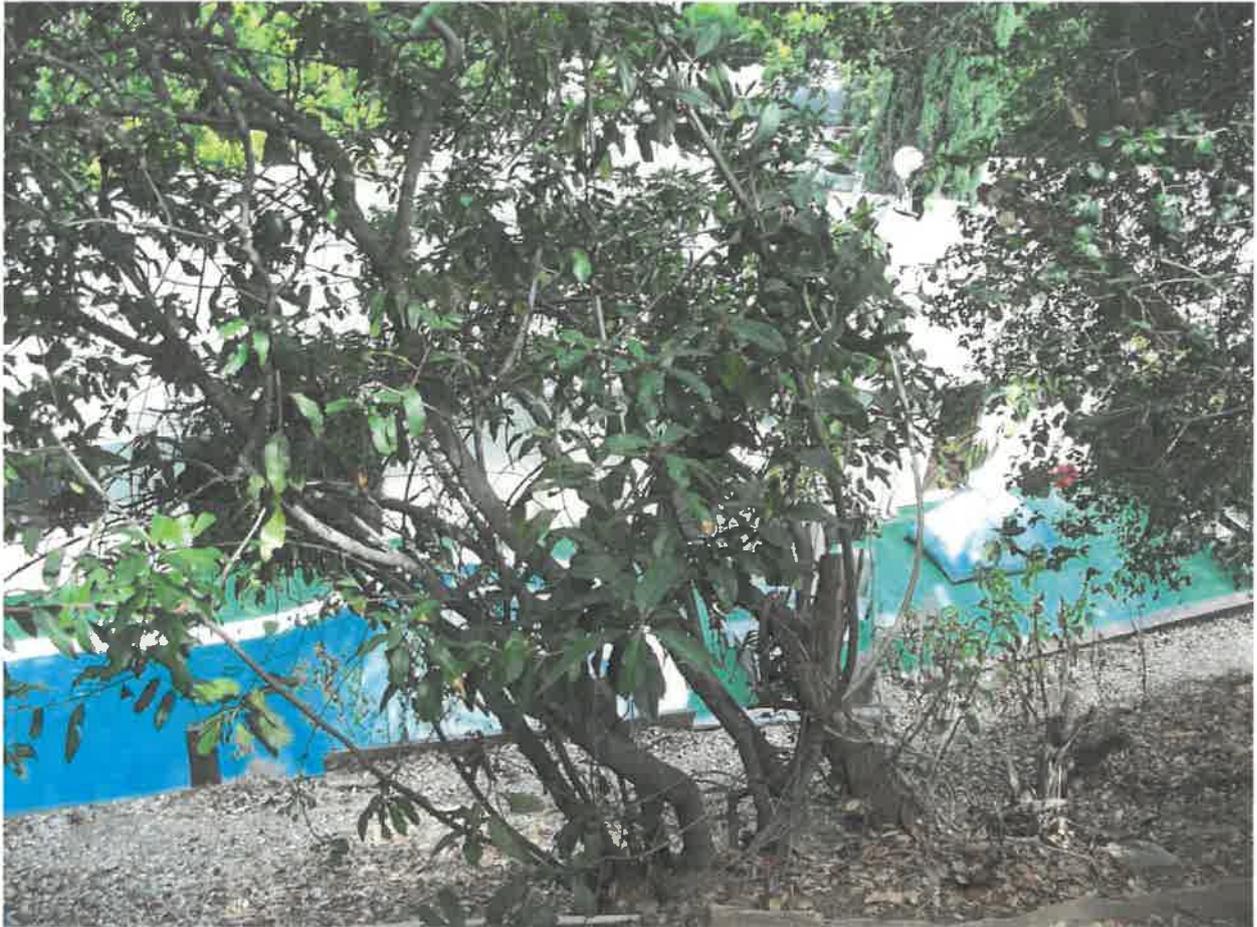
Shrub 46 is *Heteromeles arbutifolia*, Toyon, in fair condition with some dieback and poor pruning. It is 15' high and 17' wide with five 1", five 2", and two 3" calipers. This shrub should be protected in place during construction; should it be removed, mitigation value is four 24" box *Heteromeles arbutifolia*.

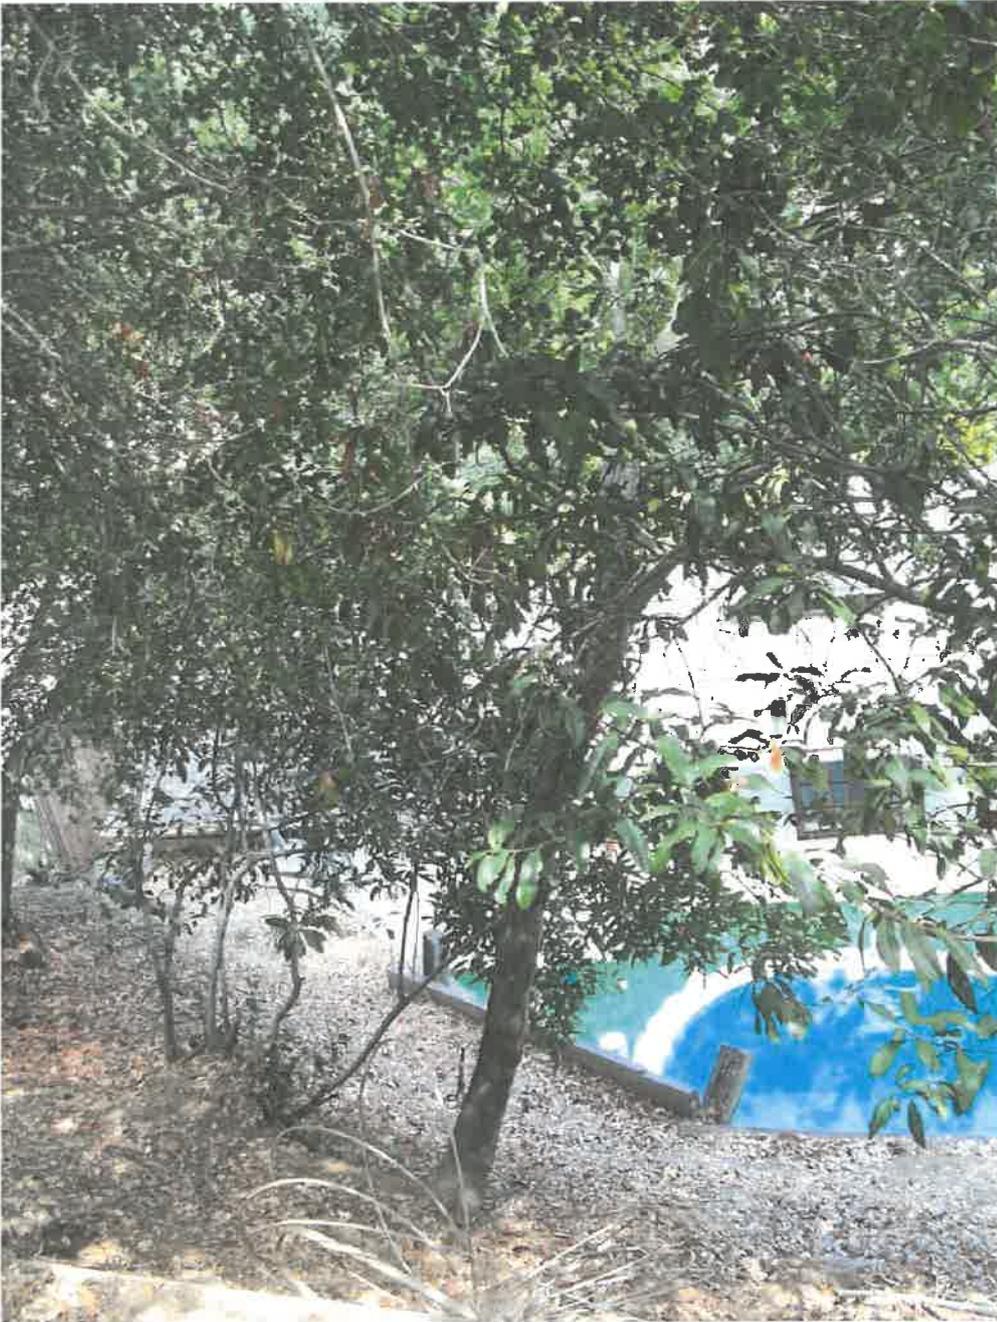
Tree 47 is *Quercus agrifolia*, Coast Live Oak, in good condition. It is 24' high and 15' wide with a 6" caliper. This tree should be protected in place during construction and might require a tree protection zone; should it be removed, mitigation value is four 24"-box trees of the same variety, *Quercus agrifolia*.

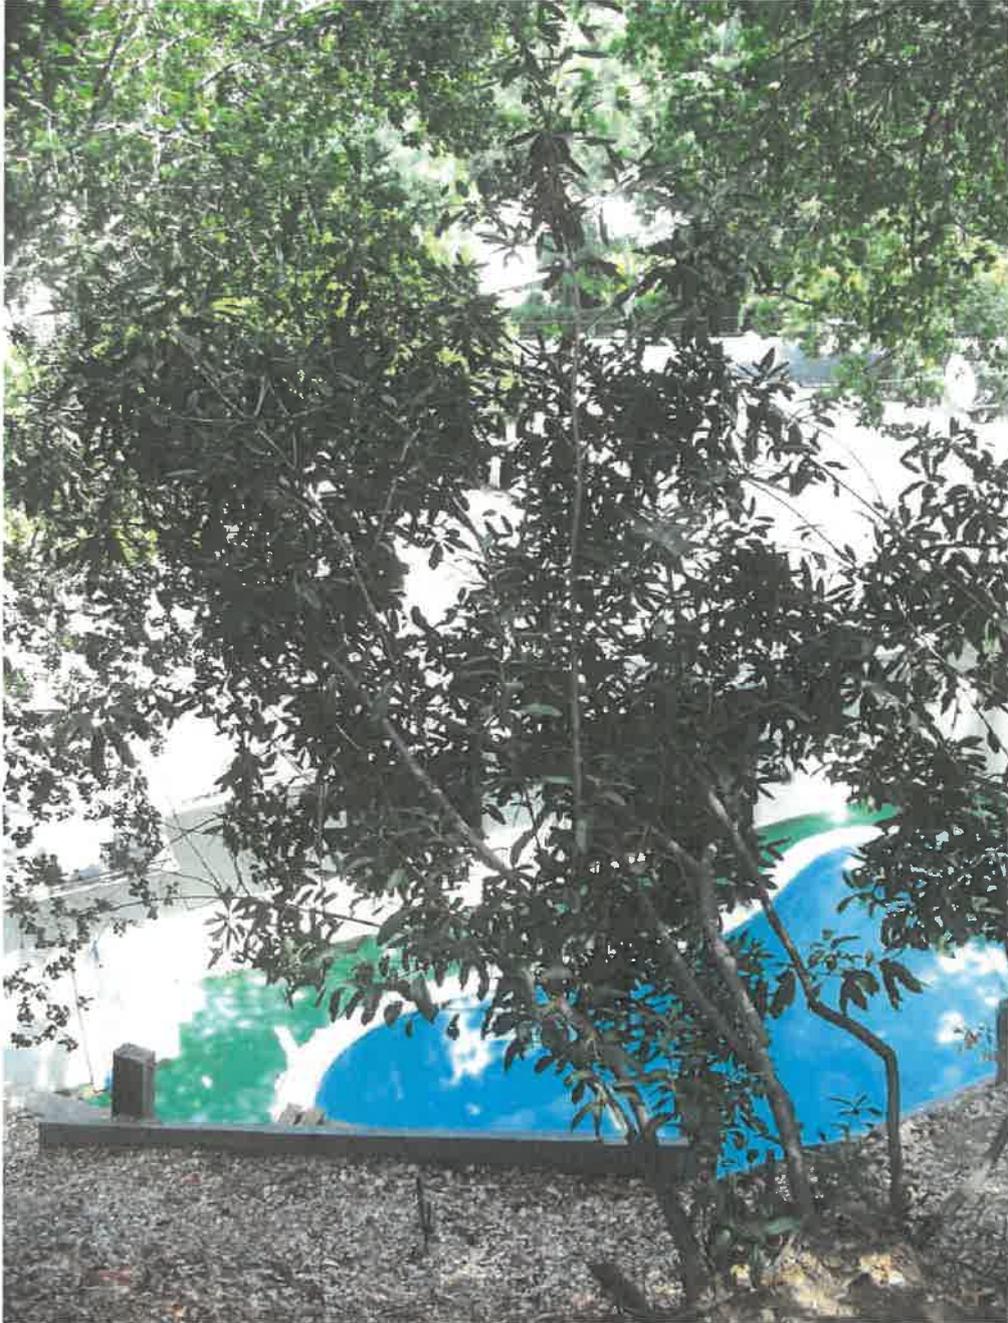
Shrub 48 is *Heteromeles arbutifolia*, Toyon, in good condition. It is 20' high and 15' wide with four 1", two 2", 3", and 5" calipers. This shrub should be protected in place during construction and might require a protection zone; should it be removed, mitigation value is four 24" box *Heteromeles arbutifolia*.

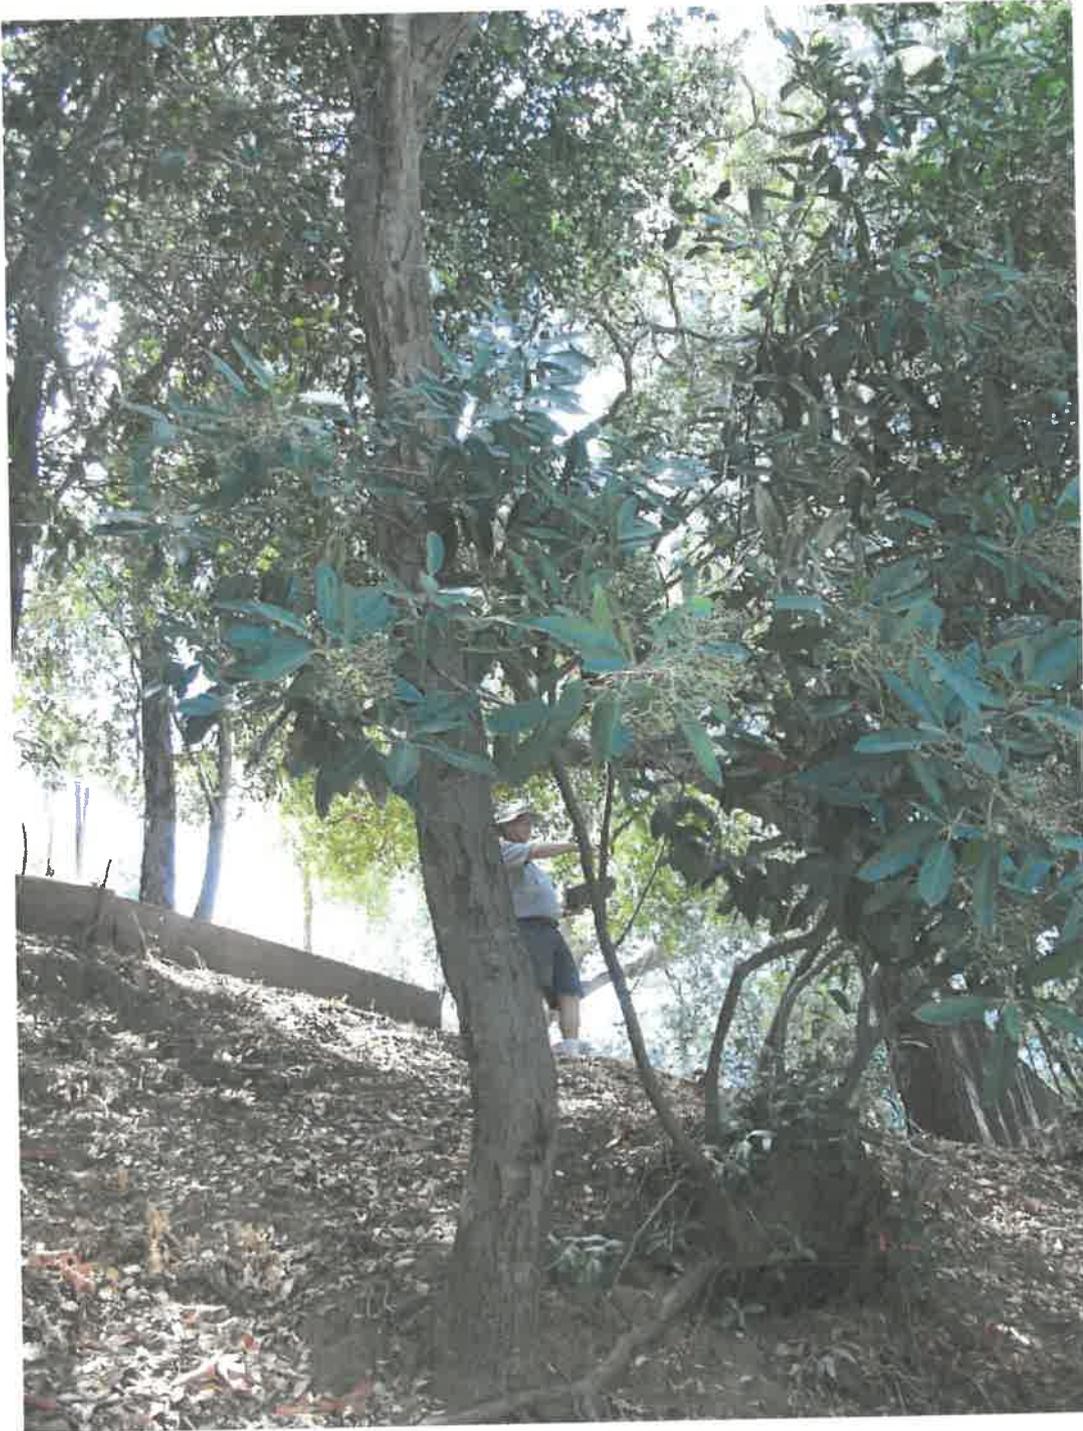
Shrub 49 is *Heteromeles arbutifolia*, Toyon, in good condition. It is 11' high and 16' wide with a 1" and five 2" calipers. This shrub should be unaffected by the construction, however, should it be removed, mitigation value is four 24" box *Heteromeles arbutifolia*.

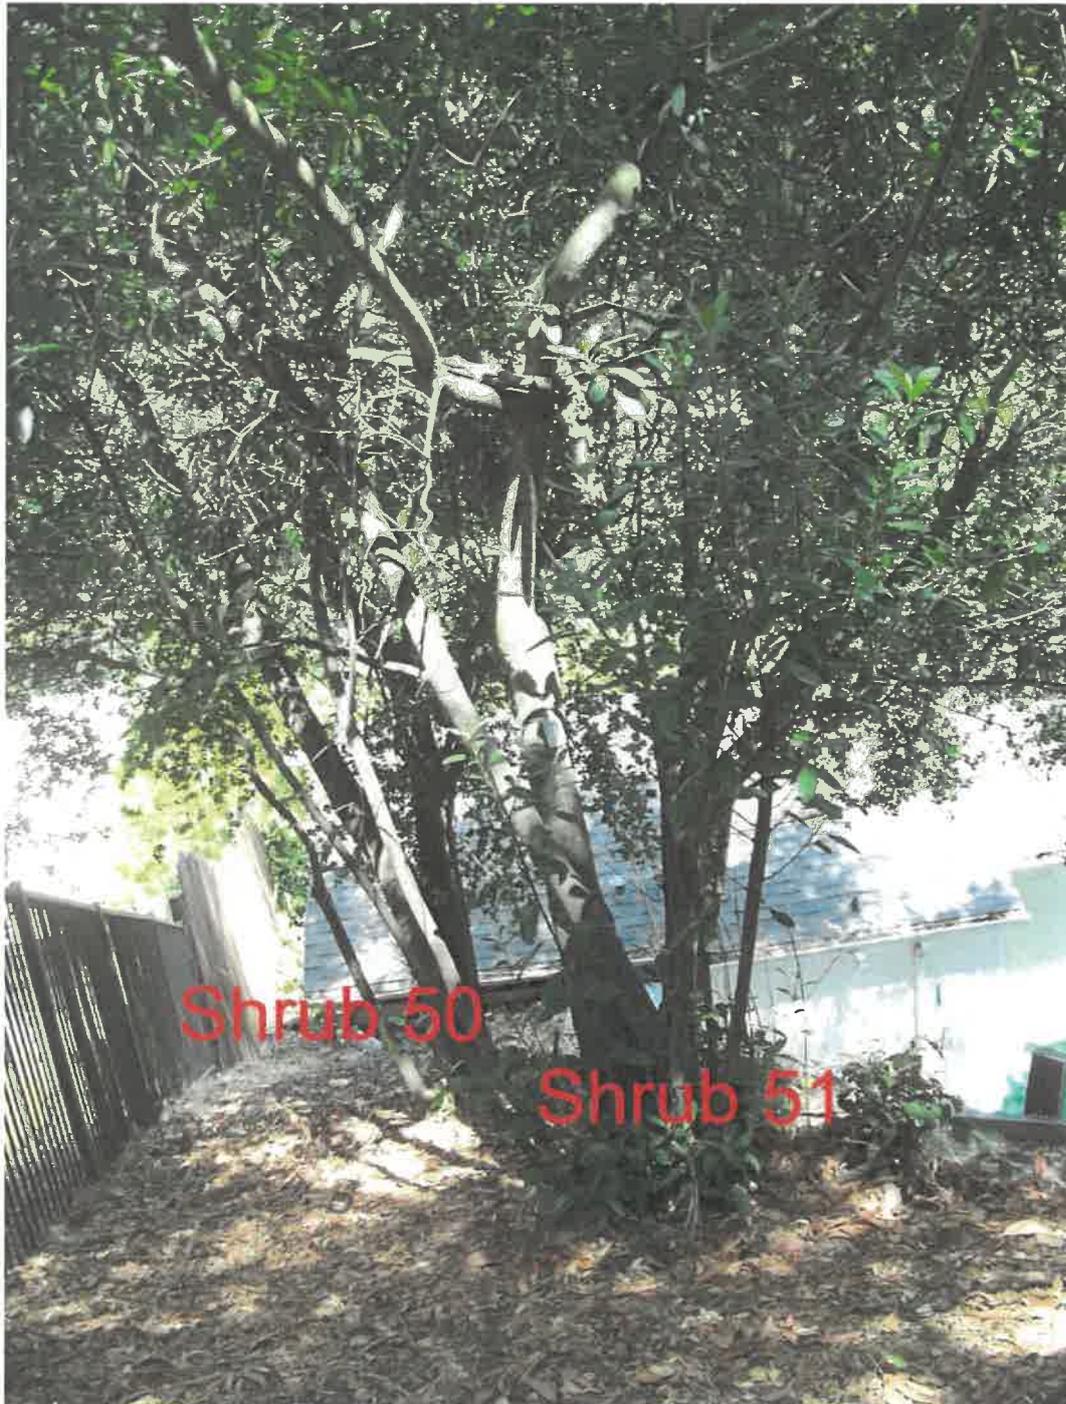
Shrub 50 is *Heteromeles arbutifolia*, Toyon, in good condition. It is 18' high and 21' wide with a three 1", 5", and 7" calipers. This shrub should be protected in place during construction and might require a protection zone. Should it be removed, mitigation value is four 24"-box trees of the same variety, *Heteromeles arbutifolia*.

Shrub 51 is *Heteromeles arbutifolia*, Toyon, in good condition. It is 26' high and 19' wide with 2", two 4", and 6" calipers. This shrub should be protected in place during construction and might require a protection zone. Should it be removed, mitigation value is four 24" box *Heteromeles arbutifolia*.

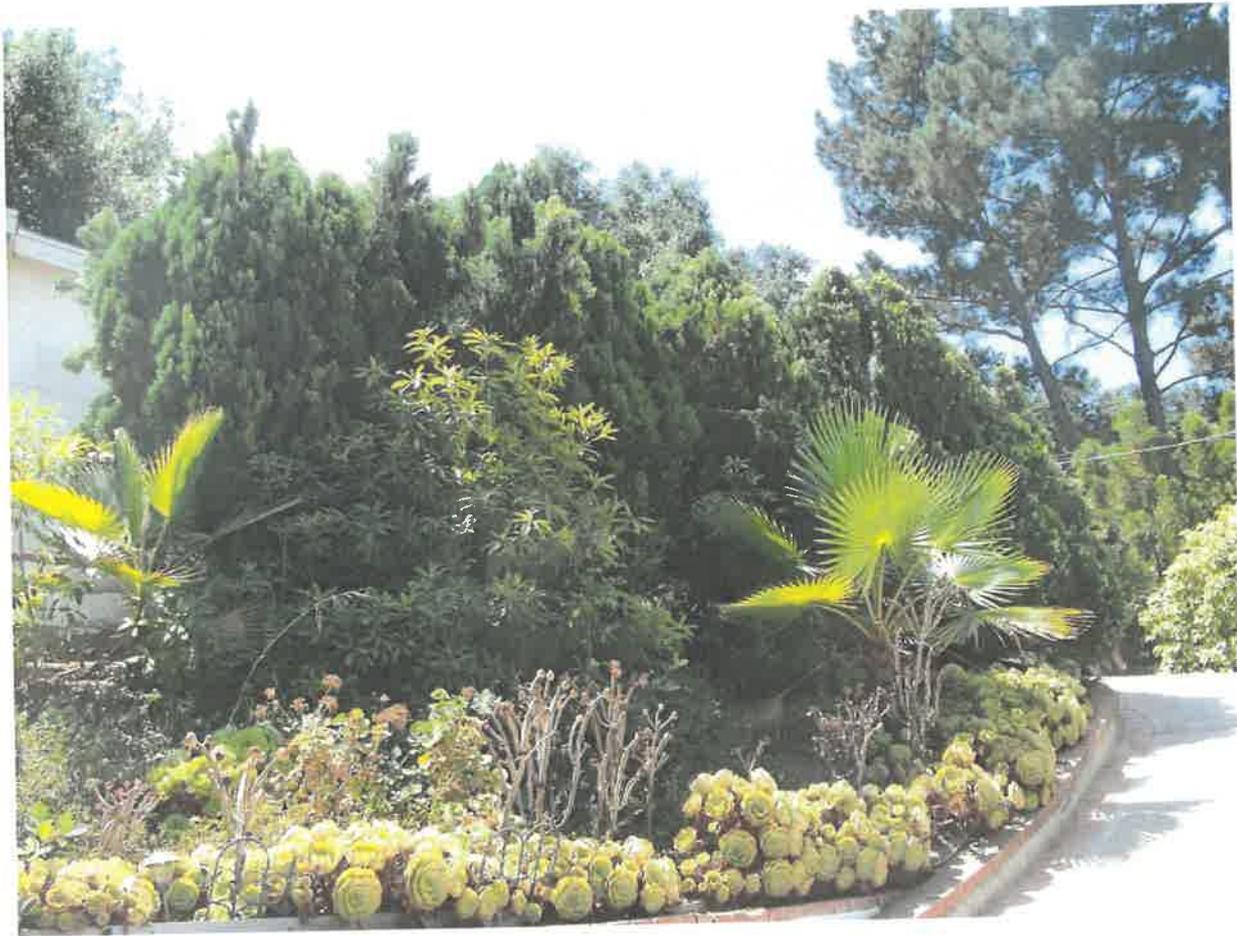
Trees 52-57 are *Juniperus virginiana*, Eastern Red Cedar, in good condition. They are approximately 11' high and 8' wide each. Their foliage was too dense to tag or measure the trunks. Should these trees be removed, mitigation value is one 24"-box tree each.
